Characterization of damages in buildings after floods in Vega Baja County (Spain) in 2019. The case study of Almoradí municipality

Ricardo Moya Barbera^{a,*}, Begoña Serrano Lanzarote^b, Teresa Escrig^c, Ivan Cabrera-Fausto^d

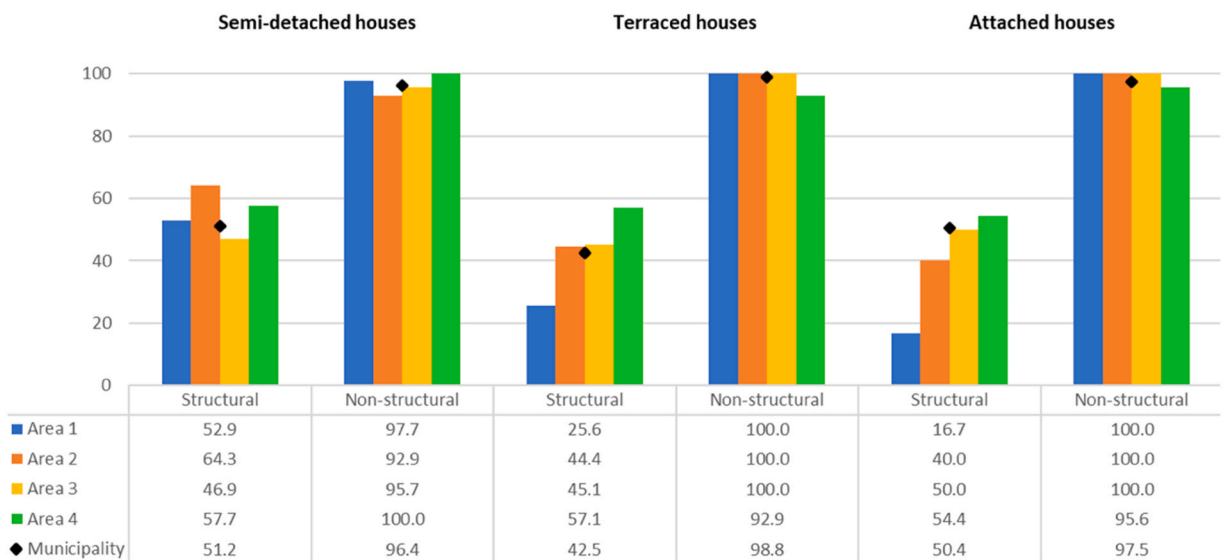
Fig. 9. Distribution of residential single-family buildings affected by structural and non-structural damages in the municipality and areas 1, 2, 3 and 4.

Almost all single-family residence types were affected by at least one non-structural damage in the municipality (more than 96%), with no significant differences in areas (less than 4%). On the other hand, around half of them suffered some structural affection, except for the ratio of terraced houses, which falls to 42.5% for the municipality. Although area results for semi-detached houses are close to the municipality, area 2 registered the highest structural damage incidence (64.3%). Conversely, terraced houses from areas 1 and 4 present the maximum difference (more than 15%) compared to the municipal data. Finally, area 4 detached houses, the only ones considered in archetype 3, present data comparable to the average. (Fig. 9).

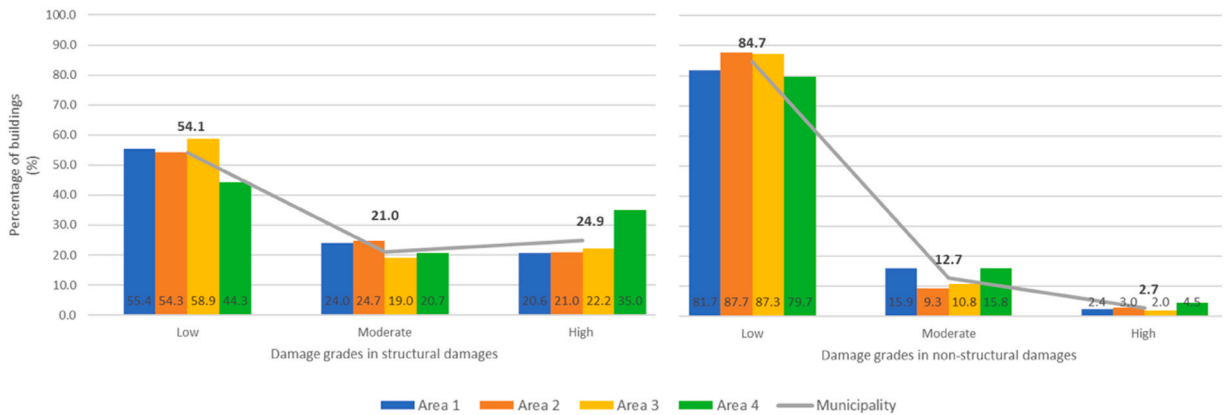
Fig. 10. Grade damage of the structural and non-structural damages registered in single-family residences for the whole municipality and the four areas.

By analyzing the grade of these damages, in all single-family types of residence, low-grade damages are the most common in both cases (84.7% and 54.1%, respectively), although with an appreciable difference of more than 30% caused by the higher occurrence of moderate and high-grade damages in structural affections. Comparing areas, A4 presents the highest number of high-grade and moderate structural damages (35% and 20.7%) and high-grade (4.5%) non-structural damages (Fig. 10).

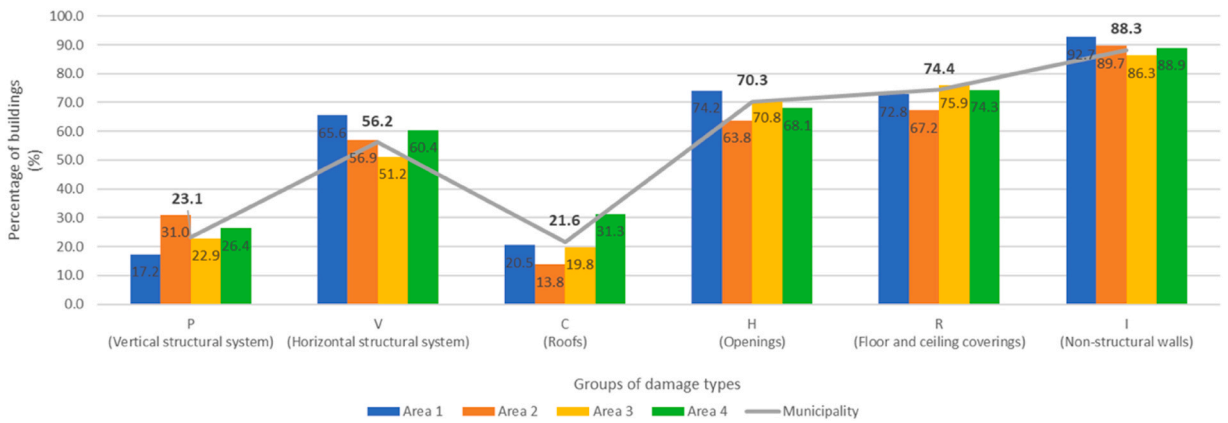
Non-structural walls (I) with 88.3%, floor and ceiling coverings (R) with nearly 75%, and openings (H) with more than 70% were the parts of buildings more widely damaged for all single-family residences; conversely, vertical structural systems (P) and roofs (C) with less than 25% were the most unusual building components affected (Fig. 11).

Fig. 11. Percentage of single-family properties affected by groups of damage types in the whole municipality and the four areas.

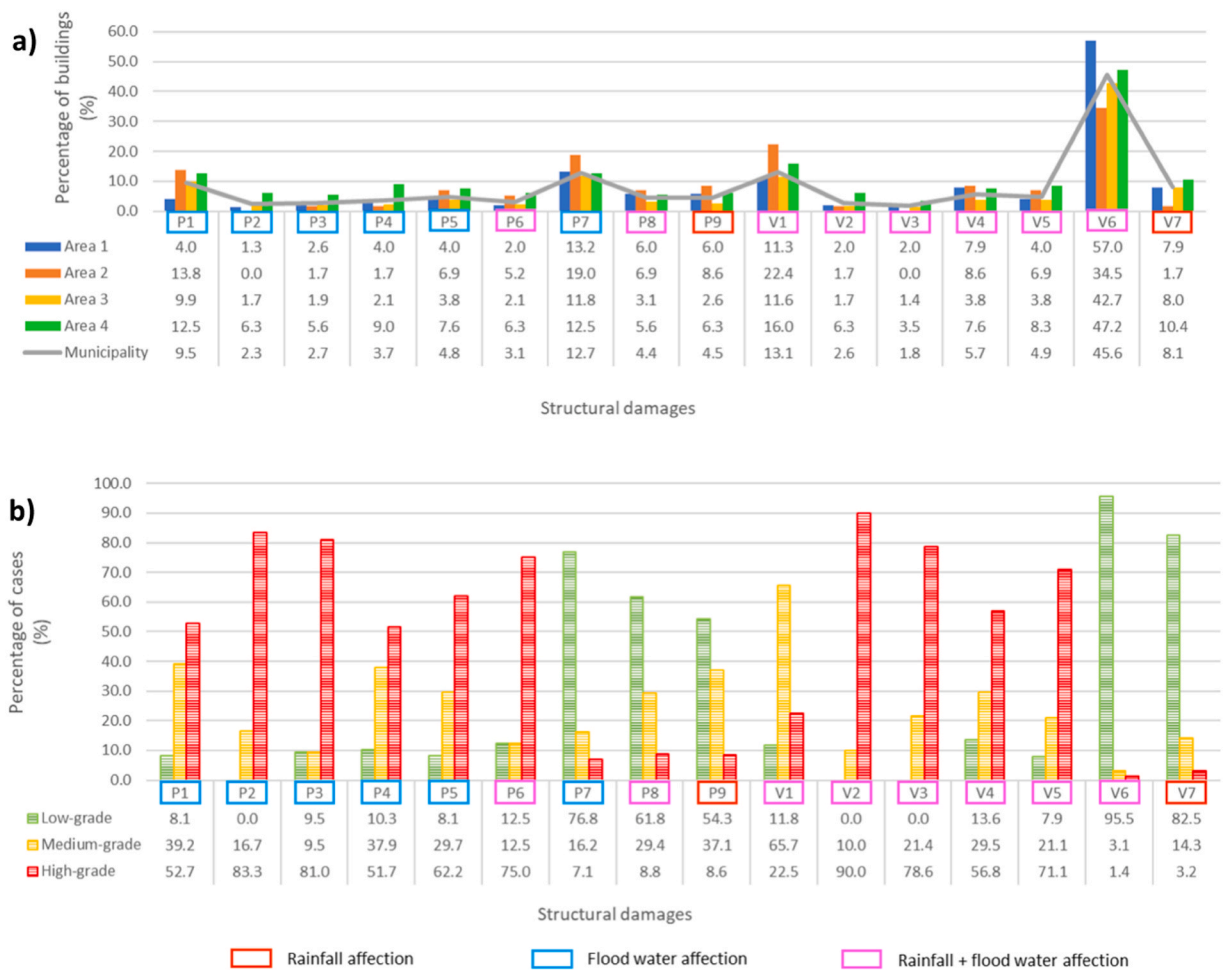
The most common structural damage types in each group are P7 - Horizontal continuous damp patches rising from lower parts and V6 - Extensive dampness on the lower part of the element, but with a significant difference in occurrence, so the first one affects less than 15% of the surveyed buildings and the other more than 45%. Nevertheless, in most cases, the grade of these damages is low (76.8% in P7 and 95.5% in V6). On the other hand, high-grade damages are widespread in damage types with the lowest incidences; for instance, collapse (P2 and V2) and diagonal cracks (P3 and V3) in vertical and horizontal structural elements affected less than 3% of properties, but more than three-quarters of these damages are high-grade (Fig. 12). As can be observed in Fig. 13, the most prevalent non-structural types of damage are I5 - Horizontal continuous damp patches rising from lower parts in non-structural walls, with 79.3% of cases documented, R2 - Deterioration of floor and ceiling coverings (65.2%) and H1 - Deterioration of windows and doors frames (63.8%). However, the most dangerous damages are C1 - Missing or broken roof coverings, with nearly 90% of cases classified as moderate and high-grade, I4 - Vertical cracks in non-structural walls (more than 75%), and C3 - Flooded roofs (practically 70%).

Fig. 12. a) Percentage of single-family properties affected by each type of structural damage, b) Percentage of low, medium, and high-grade damages by each type of structural damage.

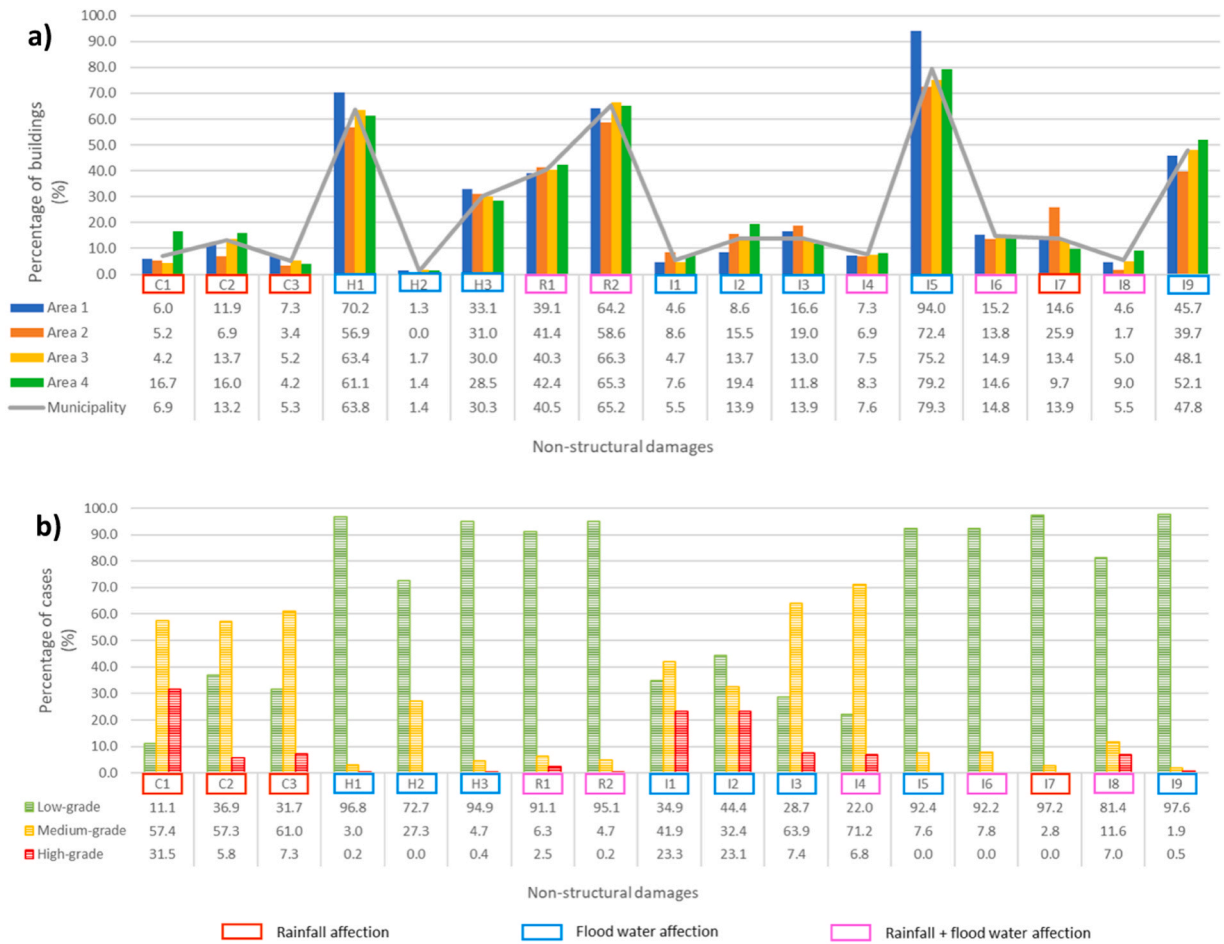
Finally, buildings affected by rain-related damages were nearly a third of surveyed buildings (32.8%), almost all by flood-related damages (93.8%) and by the combination of both (89.5%). Rain-related damages with the greatest occurrence were I7 - Small single damp patches in non-structural walls and C2 - Roof aging (13%); the flood-related damages were I5 - Horizontal continuous damp patches rising from lower parts in non-structural walls (79.3%) and H1 - Deterioration of windows and doors frames (63.8%), and the combination of both were R2 - Deterioration of floor and ceiling coverings (65.2%) and V6 - Extensive dampness on the lower part of

Fig. 13. a) Percentage of single-family properties affected by each type of non-structural damage, b) Percentage of low, medium, and high-grade damages by each type of structural damage.

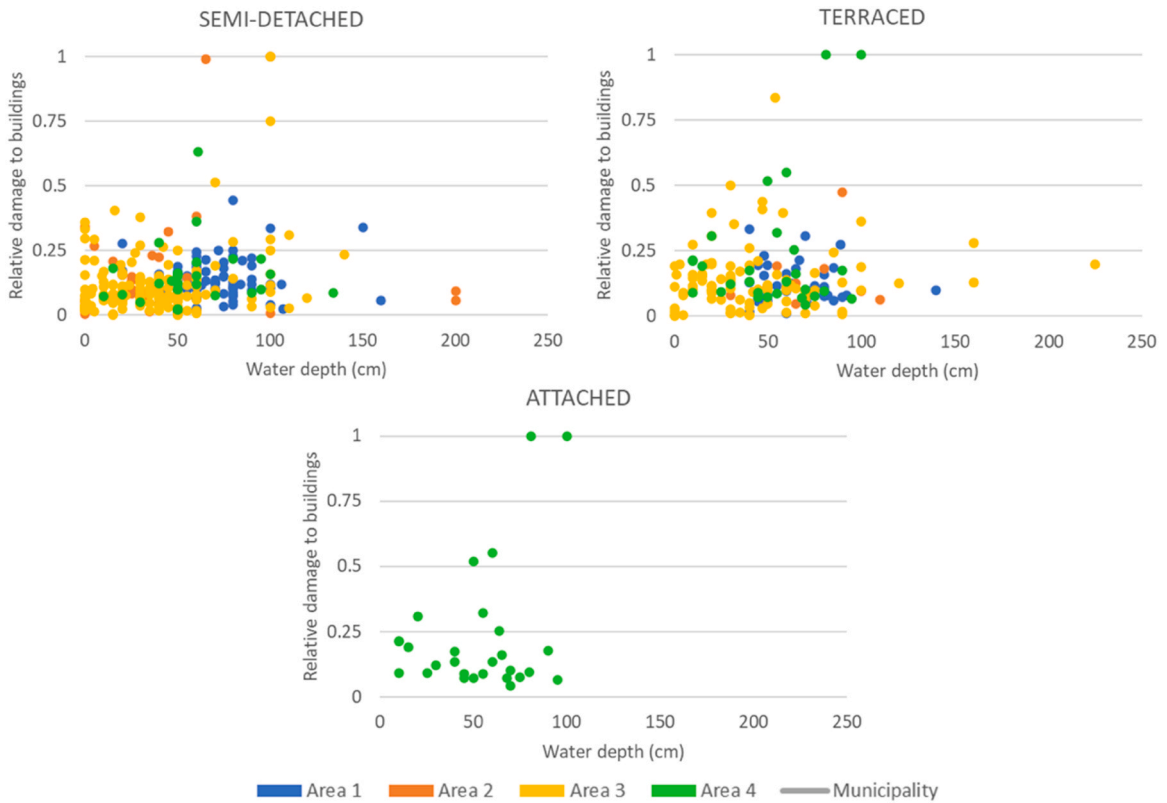
Scatter plots in Fig. 14 better show the density of estimated damage in relation to the water depth recorded for the three archetypes evaluated and their combination. Although certain variability in water depth and relative damage is appreciable, most results fall in 0–1.0 m and 0–0.25% ranges. In addition, Box plots in Fig. 15 and Table 7 show the distribution and the maximum, minimum, and average values of relative damage, respectively, for the same property types. Note that average relative damage is related to water depth, so the higher the flood depth, the higher DRD average ratio. However, detached houses show a slightly different distribution in comparison to semi-detached, terraced, and single-family properties whose average DRD values for ≥ 80 cm are around 1.6–2.0 higher than for ≤ 15 cm, along with a moderate growth trend up to 46–79 cm (around 0.02 per flood depth range), after which it increases considerably for the highest depths (0.05–0.07). In contrast, detached houses show the highest DRD values for deeper flood levels and the highest difference compared to lower levels (more than three times higher), and remarkable growths up to 16–45 cm (1.6–2.5 times more accentuated than the rest of building types) and up to 46–79 cm (3.6–5.3). This is a consequence of the different flood exposure and resistance features of Area 4 detached houses, which mainly are single-storey properties (80.9%) built before 1960 (67.1%) with the lowest ratio of modern constructions (19.7%), the highest percentage of low-quality (32%) and poorly maintained (16.4%) buildings, and the lowest of high-quality (35.3%) and well maintained (67.2%).

Fig. 14. Scatter plot of relative damage (y-axis) in relation to observed water depth (x-axis) for the three archetypes analyzed (semi-detached, terraced, and attached houses) by areas.

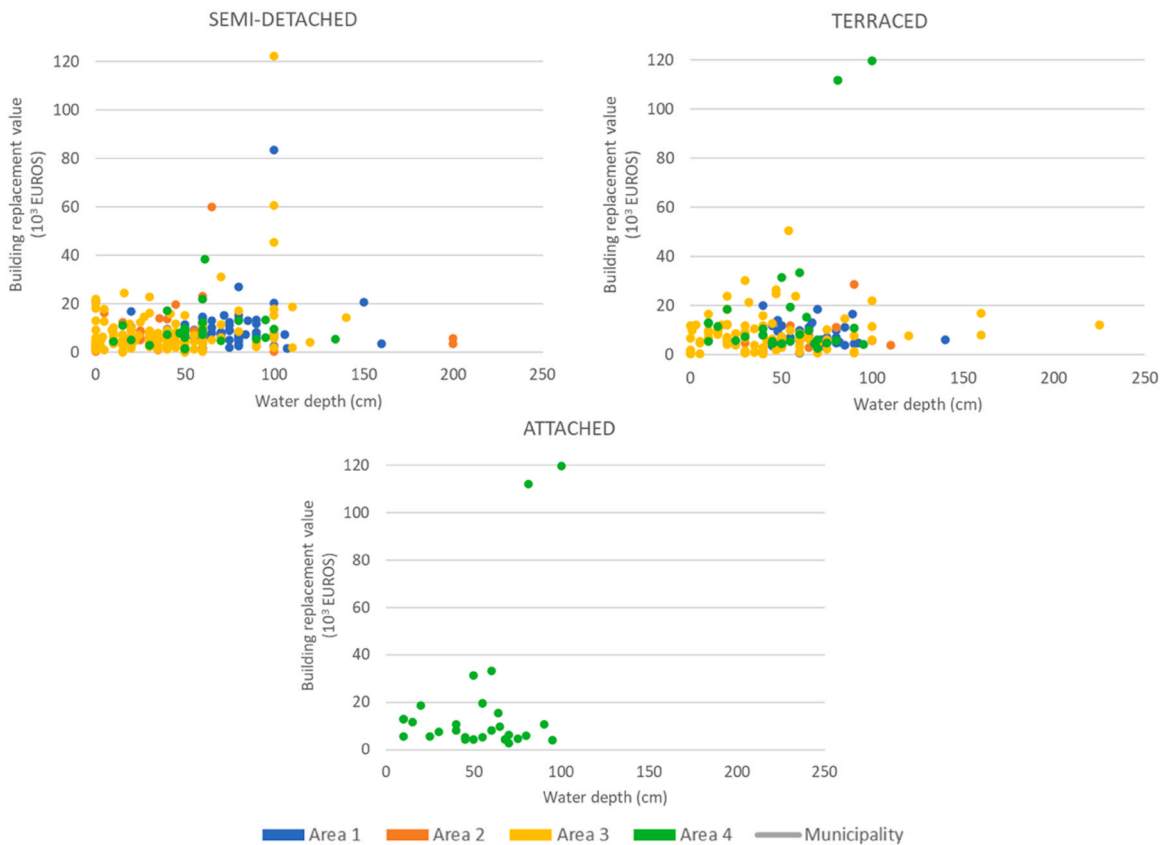
Absolute damage to buildings or building replacement value shows similar pattern results as relative damage, concentrating most of the results in 0–20,000 EUROS and the same flood depth (0–1.0 m) for all building types and areas considered, as shown in the scatter plots in Fig. 16, and the box plots in Fig. 17. Likewise, Table 8 frames the correlation between water depth and the absolute losses. However, it also highlights, along with DRD, the non-linear relation between water depth and cost of replacement, reaching remarkable increments for higher flood depths (≥ 80 cm), except for detached houses, which follow the same trend as in DRD values,

Fig. 16. Scatter plot of absolute damage in thousands of EUROS (y-axis) in relation to observed water depth (x-axis) for the three archetypes analyzed (semi-detached, terraced, and attached houses) by areas.
