TRABAJO FIN DE GRADO EN INGENIERÍA EN TECNOLOGÍAS INDUSTRIALES.

ANALYSIS, DIAGNOSIS, AND REDESIGN OF AN INDEXING TABLE INCORPORATED IN A CAMSHAFT PRODUCTION LINE.

AUTHOR: Llac Hernández Llinares.

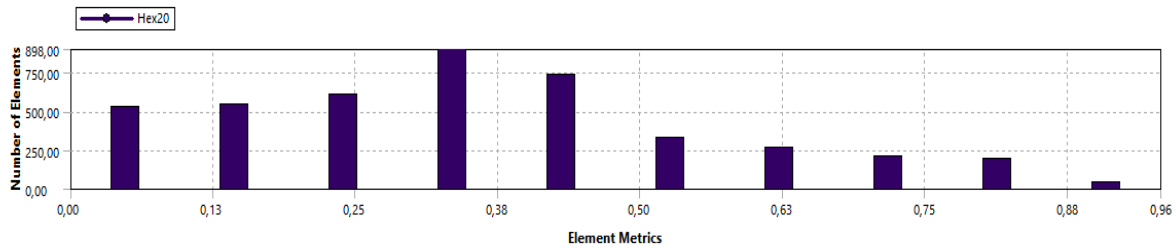
Chart 1: Original bearing mesh quality.

Mesh quality: According to Ansys' standards, a skewness under 0,5 means that the element is functional, between 0,5 and 0,75, it is fair, and over 0,75, the element is poorly shaped. We can see in chart one that most of the elements are under 0,75. Nevertheless, there are elements over this value, but these correspond to elements that make up the mesh of the inferior surface, which is not of our interest.

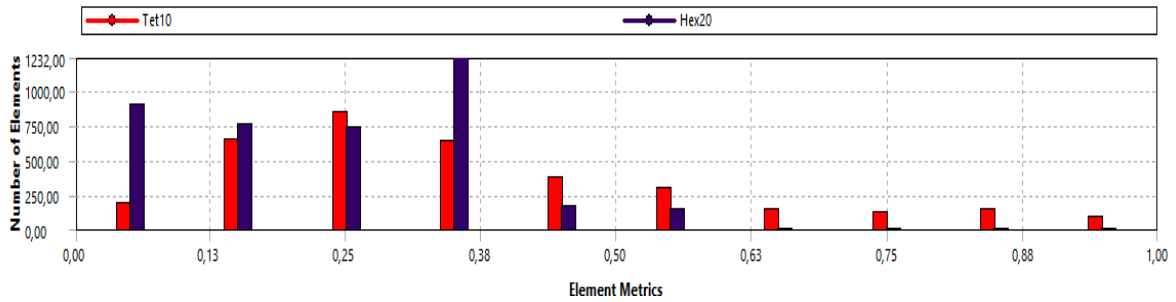
Chart 2: New bearing mesh quality.

In this case, we have two types of elements, tetrahedral and hexahedral, to have a better fit to the shape of the bearing. Also, in this case, the elements over 0,75 are placed in the inferior washer. Now, we do mount this element, but since it is not critical because the force is applied to the superior washer, we consider this **mesh as reliable**.

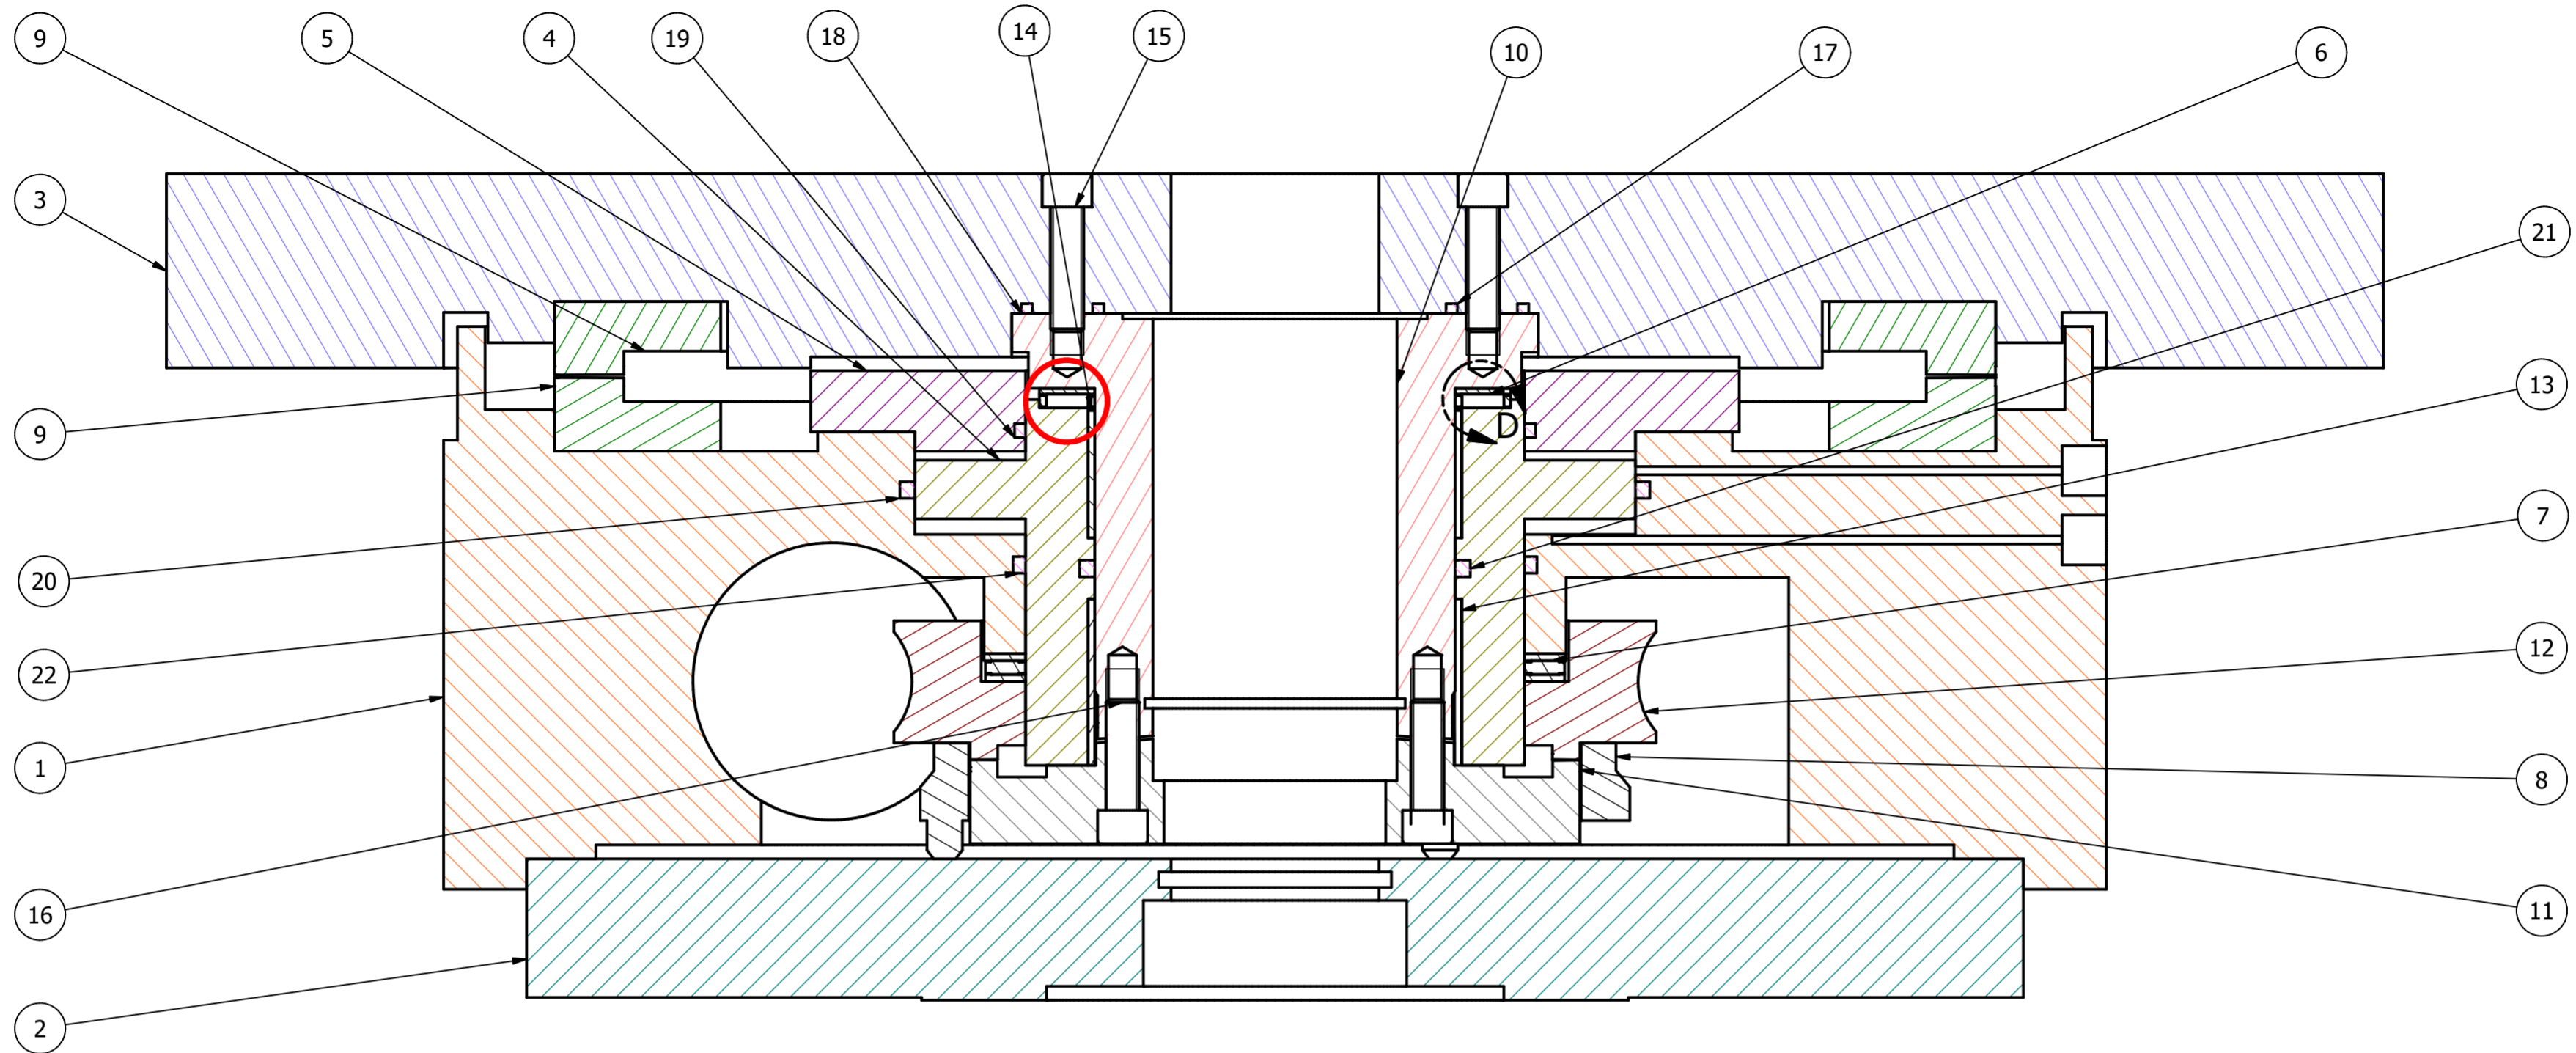
The inferior rolling surface of the bearing was not mounted in the original design. The surface of the piston is in contact with the rolling elements. This is the cause of the breakdown.

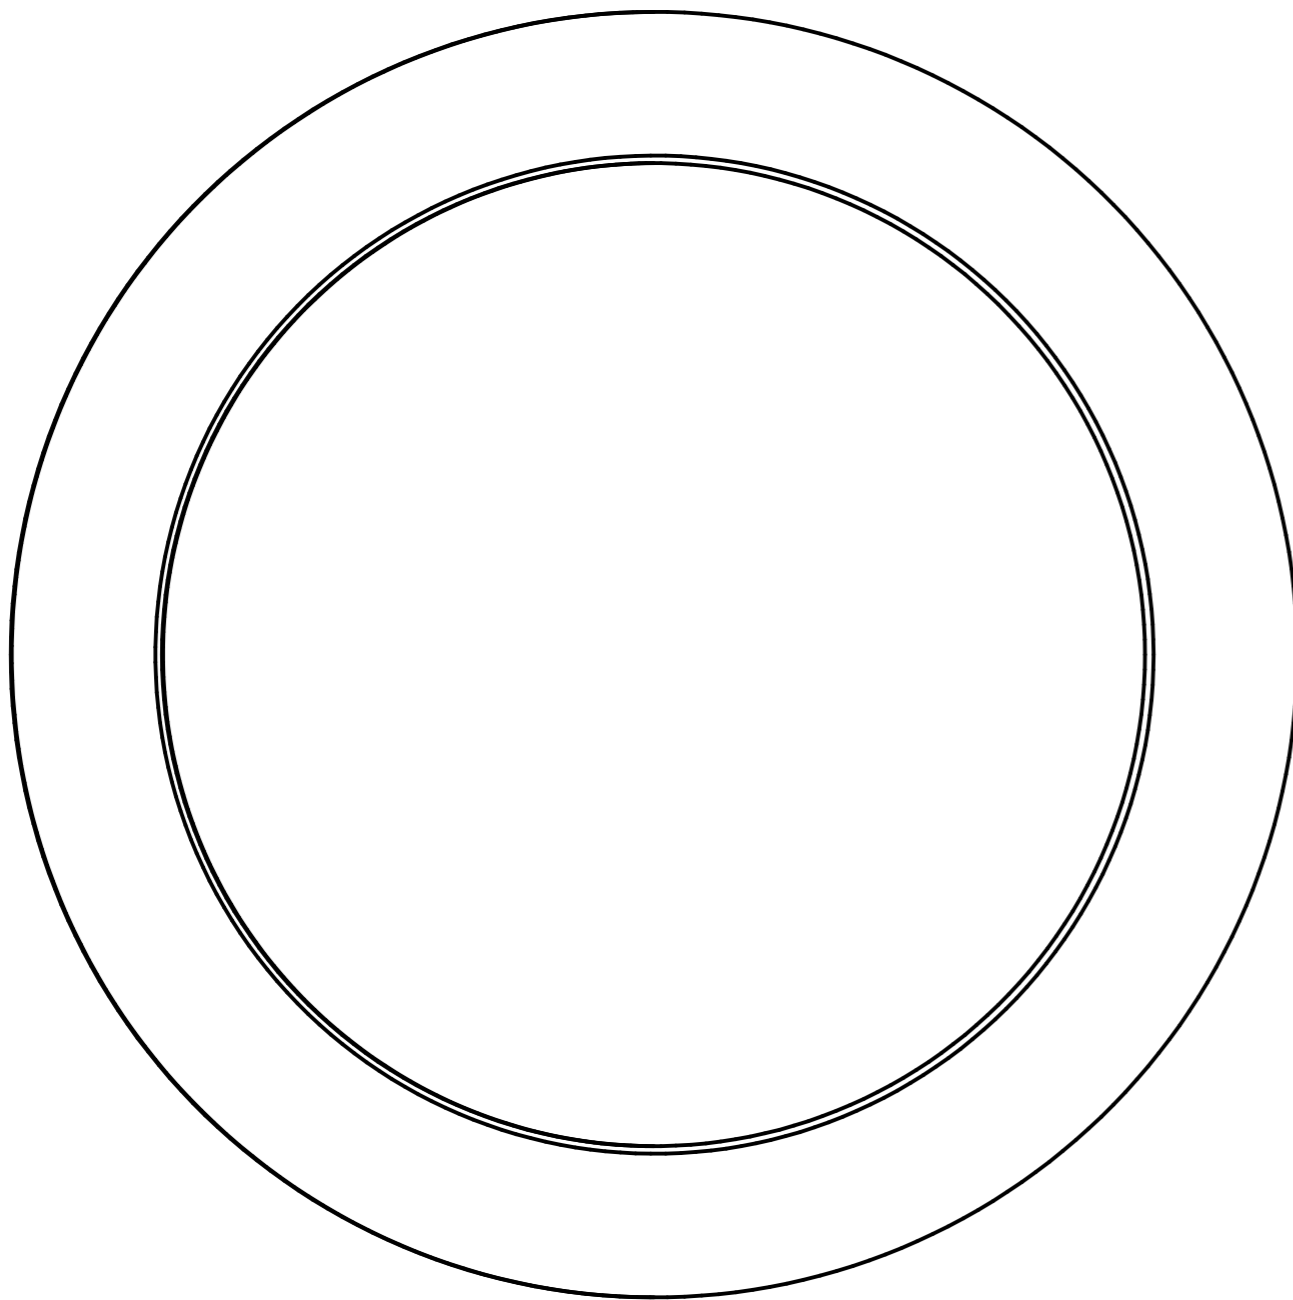
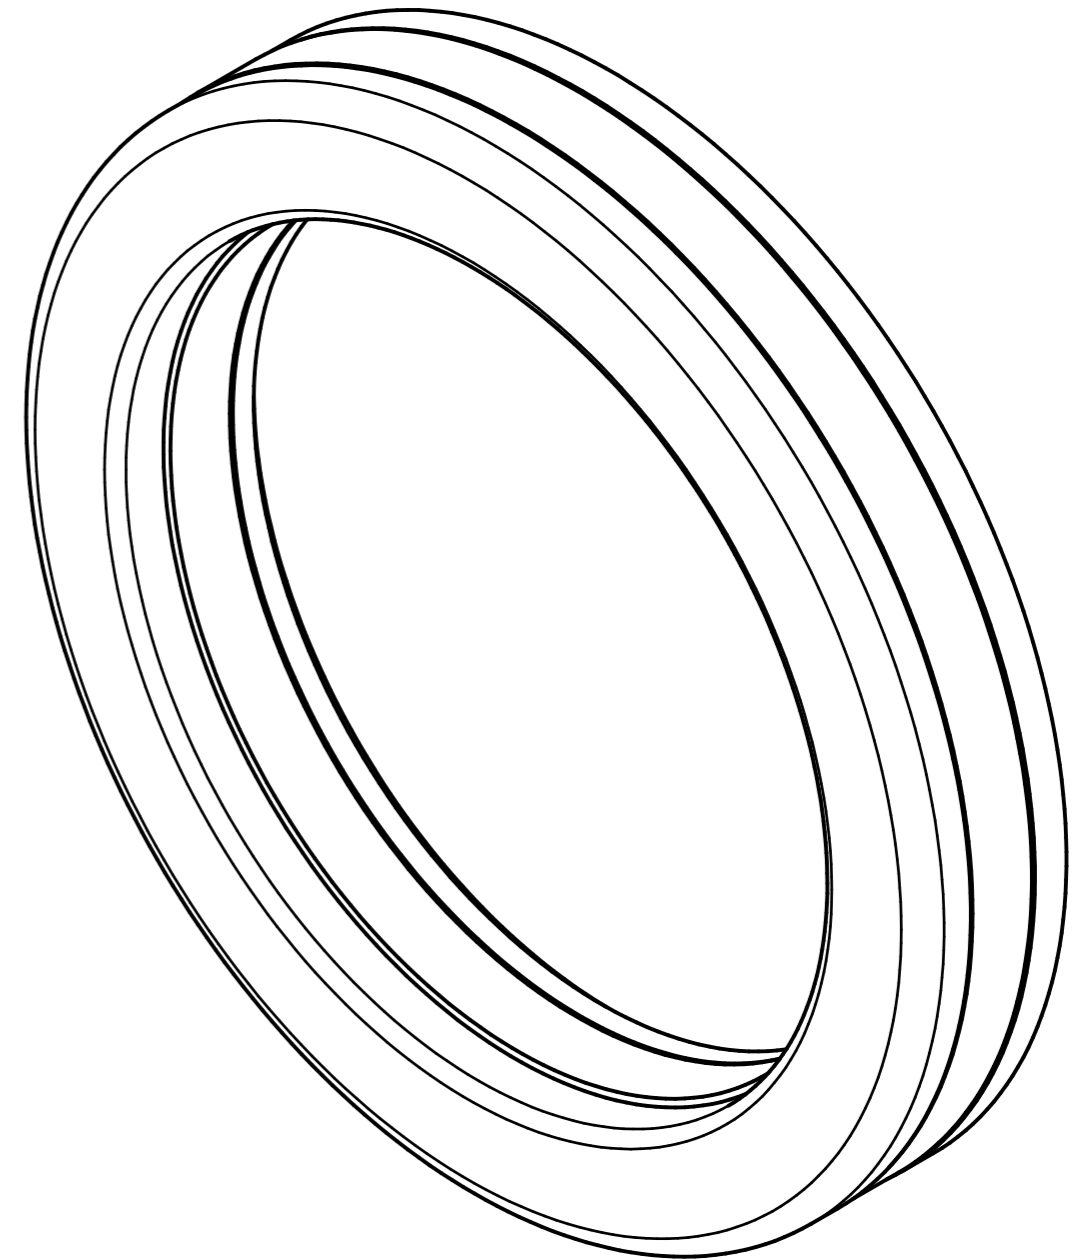
Rolling surfaces: LS130170

Normalized component. Drawing
made from nominal measures.
Modified upper surface.

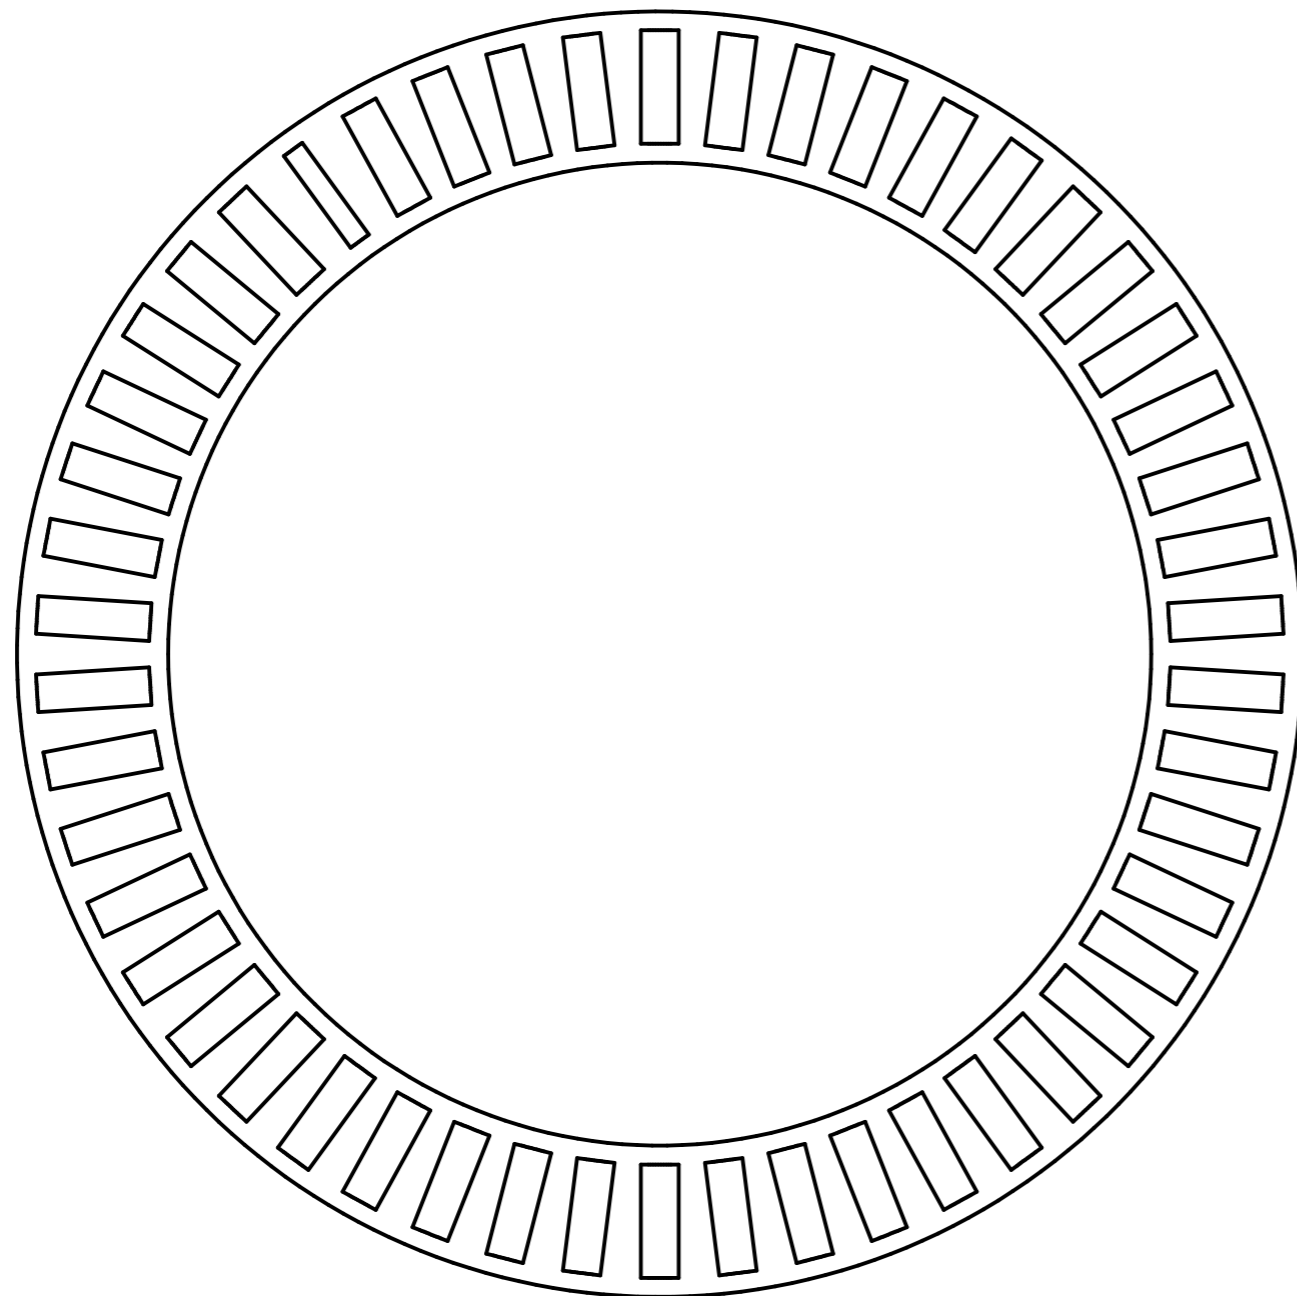
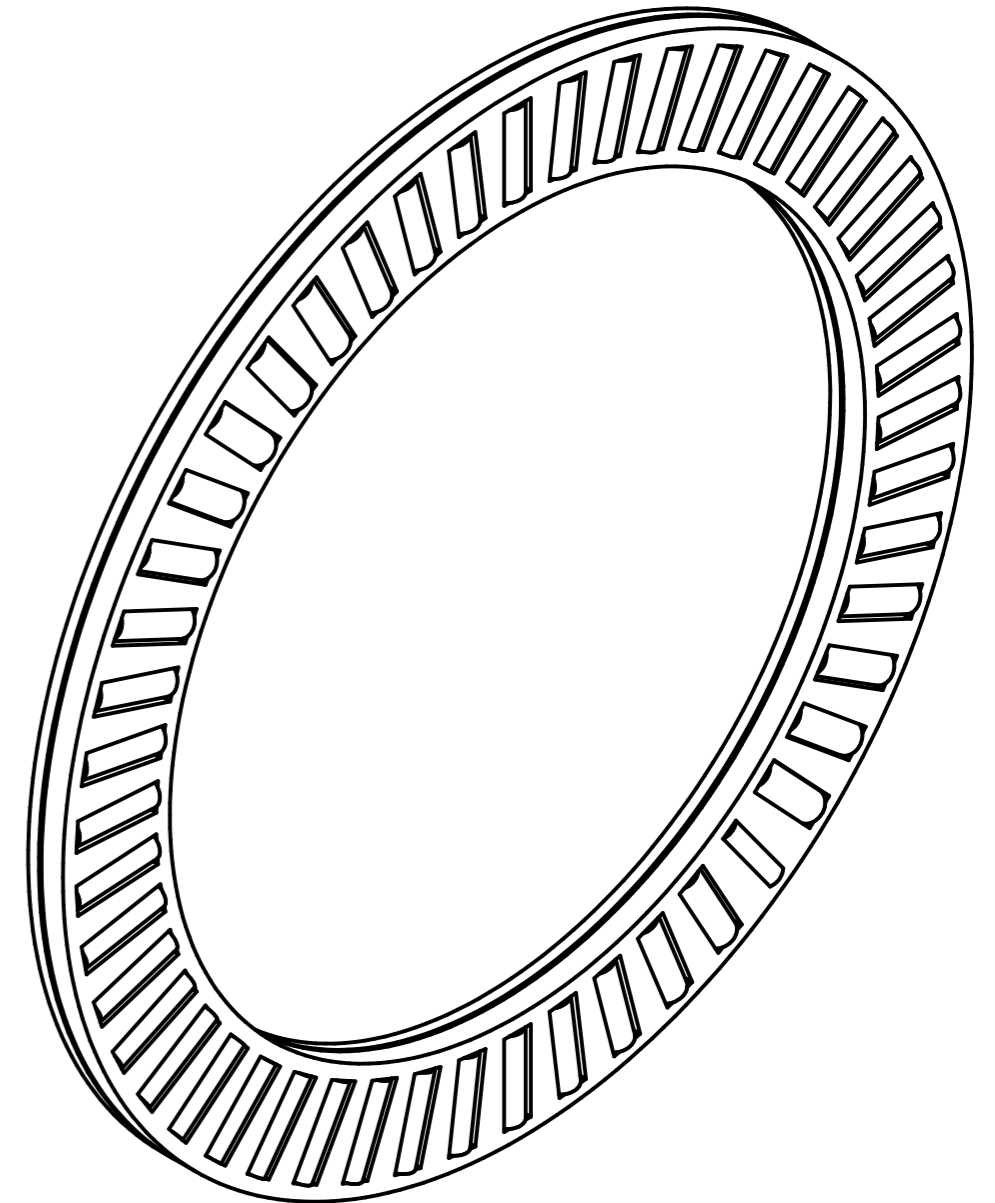
Rolling surface: AS130170.

Drawing represents original mounting of the bearing, with just the superior rolling surface mounted.
