Daugiabučio gyvenamojo namo Trakų g. 14 Vilniuje rekonstrukcijos projektavimas
Reconstruction planning of the multi-dwelling residential building at Traku str. 14 in Vilnius

FINAL THESIS WORK

VILNIUS, 2013

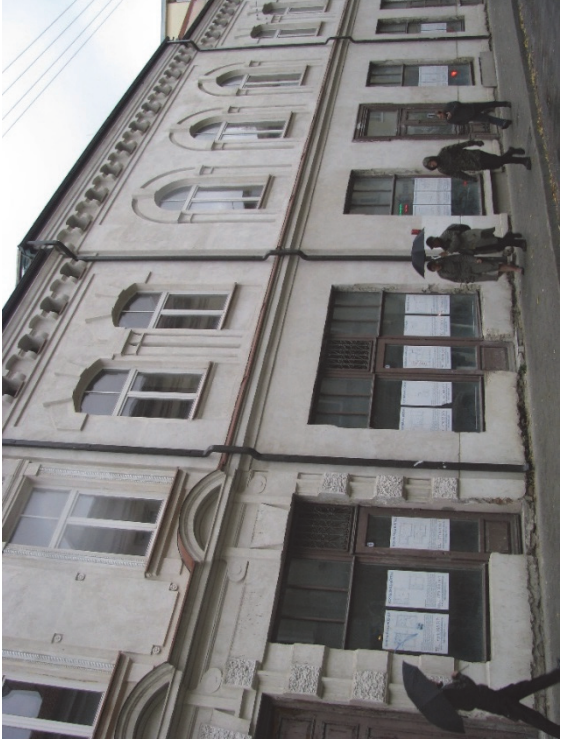
Figure 4 . Picture of Traku street facade before the reconstruction works started

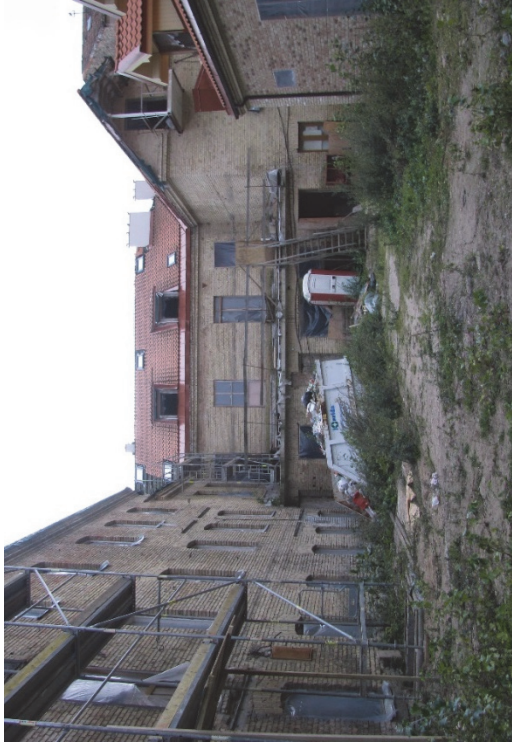
Figure 5 . Picture of the courtyard before the reconstruction works started

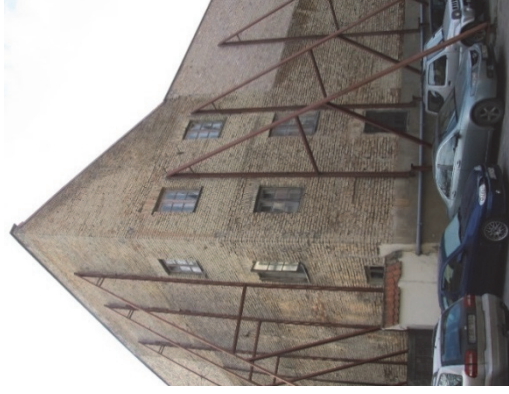
Figure 6 . Picture of the steel structure reinforcement for the reconstruction works

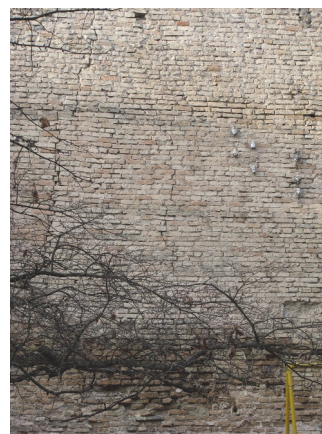
Figure 57. Exterior eastern wing facade before the reconstruction works

The next pictures show the material (Figure 59) and the process of the Stitching (Figure 60) used for the reparation of cracks in walls with Brickfix Crack Stitching System method.

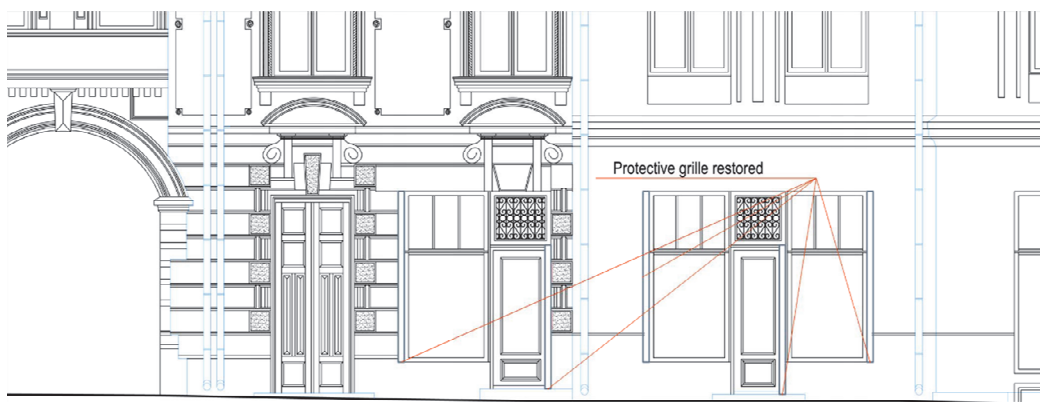
The following picture (Figure 74, Figure 75) and the draw (Figure 76) represent the state of the access of Traku Street before the reconstruction works started and the indication of the new demand for the grille.

Figure 76. Demand of the protection grille for some access in the Facade draws

The solution adopted is to place a gate hinged metal that will be used to protect the glass windows of the main street facade. In the next pictures (Figure 77, Figure 78) is possible to see the replacement of all the doors and windows of this facade as well as the rehabilitation of the sockets and repainting the entire facade.
