SEISMIC PERFORMANCE OF MASONRY RESIDENTIAL BUILDINGS IN LORCA'S CITY CENTRE, AFTER THE 11TH MAY 2011 EARTHQUAKE

Luisa Basset-Salom¹; Arianna Guardiola-Víllora

ABSTRACT

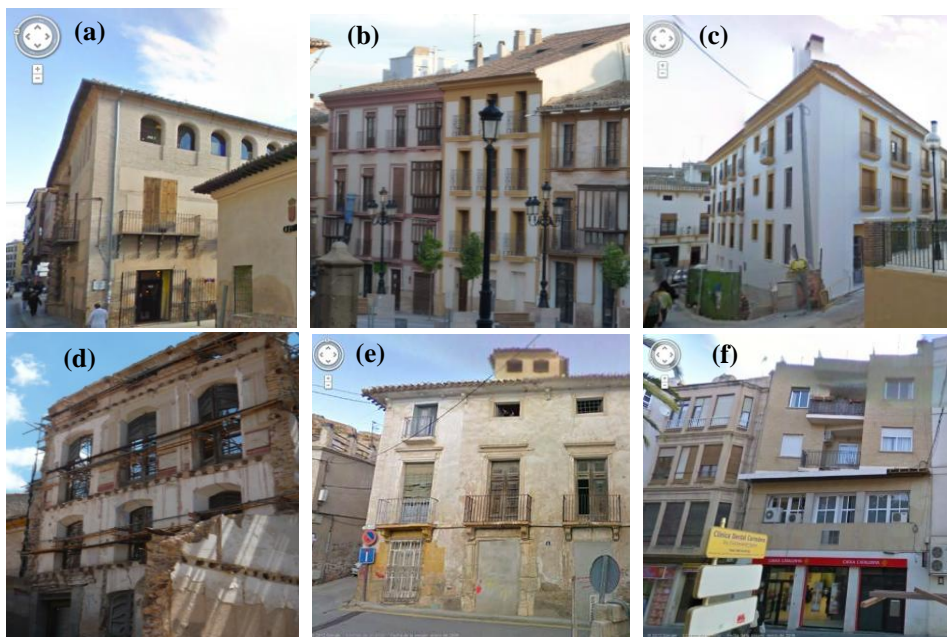
The urban layout of this area results in irregular blocks, subdivided into plots of different dimensions and different street fronts, depending mainly on the street location. The building stock is very heterogeneous: (a) full restored and well maintained mansions with residential or administrative use, (b) traditional masonry residential buildings with different levels of maintenance, (c) new apartment dwellings replacing the inside of a traditional building but keeping the original masonry façades without structural use, (d) cleaned up buildings with braced façades, (e) abandoned buildings waiting to be declared ruined and (f) new reinforced concrete buildings built from 1970 to 2000 (see figure 5).

Fig. 5 Buildings in the surveyed area, before the earthquake: **a)** fullrestored mansions with residential or administrative use, **b)** traditional residential buildings, **c)** new apartment dwellings, **d)** cleaned up buildings, **e)** abandoned buildings and **f)** new reinforced concrete buildings (Google Street View)

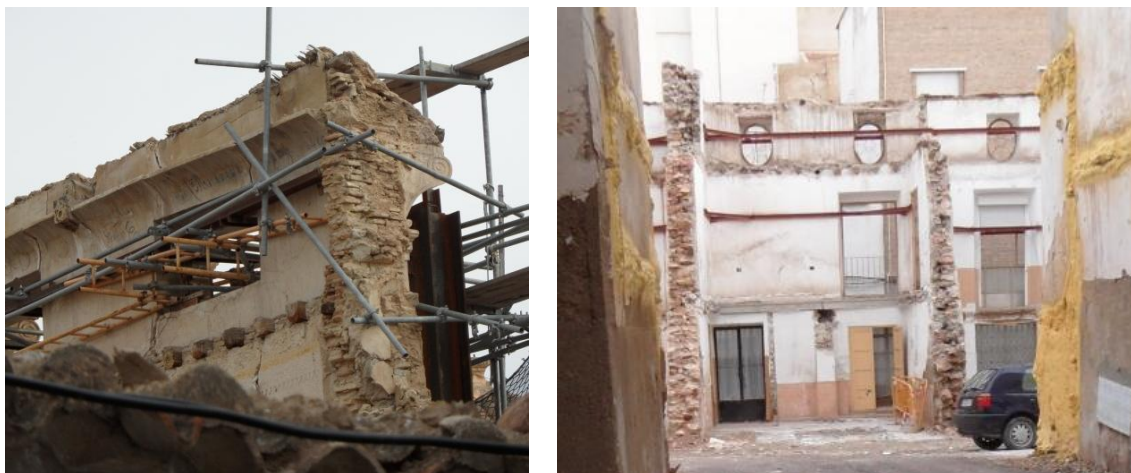
The vertical structural system of traditional URM residential buildings in Lorca consists of load bearing orthogonal walls forming the street façades (or the main façade and the interior courtyard façade) and the party walls (figure 6). Sometimes, depending on the building plan, there are interior walls with structural function.

Fig. 6 Vertical load-bearing masonry walls: Street façades and party walls

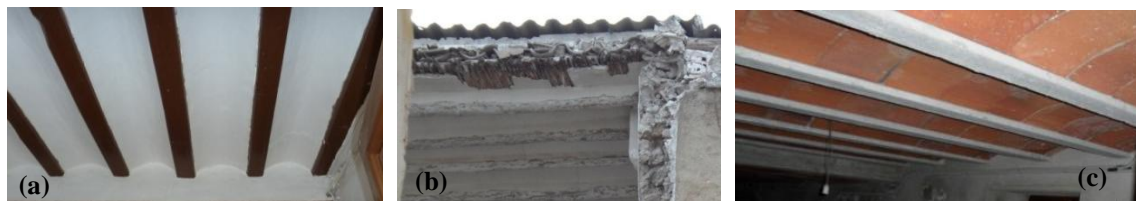
The original horizontal structures are made of timber beams for lintels, beams and joists with lightweight masonry vaults in floors or with a traditional covering made out of a reed and plaster deck (named “cañizo”) or a brick deck under ceramic curved tiles in roofs. Recent floors are made of RC beams and joists with ceramic vaults (figure 7). Floors and roofs are carried out either in the façades and the inner walls or in the party walls.

Fig. 7 Horizontal structures: **a**) timber floors (timber beams and joists with lightweight masonry vaults), **b**) roofs (reed and plaster deck, “cañizo”, under ceramic curved tiles) and **c**) new RC floors (RC beams and joists with ceramic vaults)

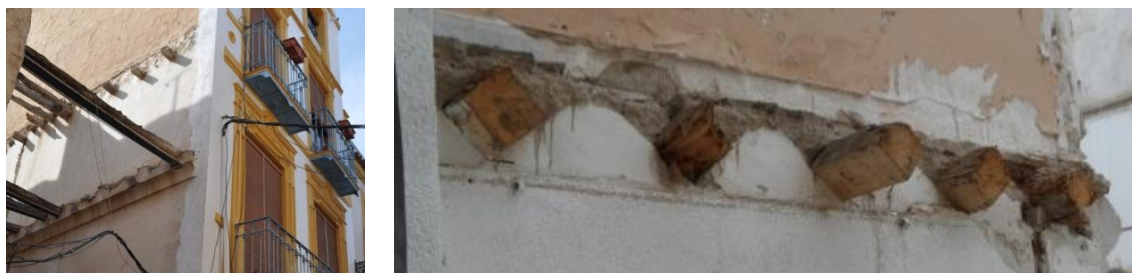
Frequently, buildings in a block share the party walls, presenting also a continuity of the horizontal structure and the roof overhang, either because they were built at the same time or because new buildings in between two older ones used the existing walls (figure 8). In these situations attention has been paid to possible coupling effects, considering buildings together instead of individually.

Fig. 8 Shared party walls

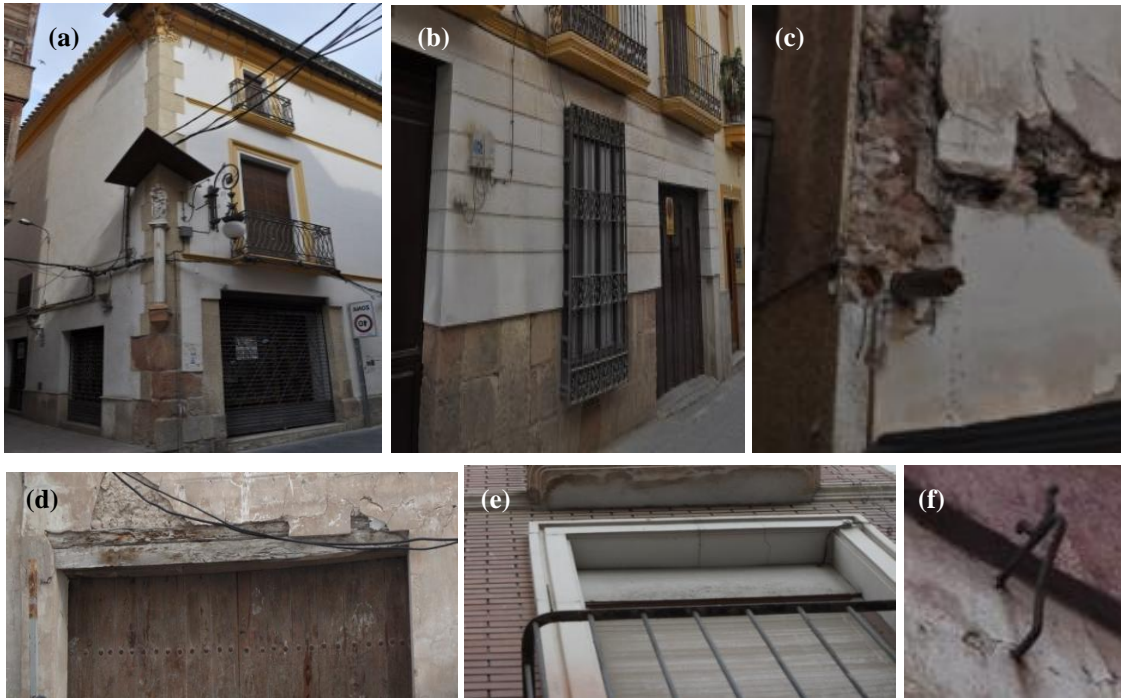
Being Lorca in a region of moderate seismicity, some reinforcement elements can be found: stone quoins in one or more storeys, plinths, floor and wall timber ties or timber ring beams placed horizontally in the middle of the thickness of the wall, timber lintels, stone frames around openings and a few iron ties connecting the façades to the floors or to the orthogonal walls (figure 9).

Fig. 9 Reinforcement elements: **a)** Quoins, **b)** Plinths, **c)** Floor and wall timber ties or timber ring beams, **d)** Timber lintels, **e)** Stone frames around openings and **f)** Iron ties

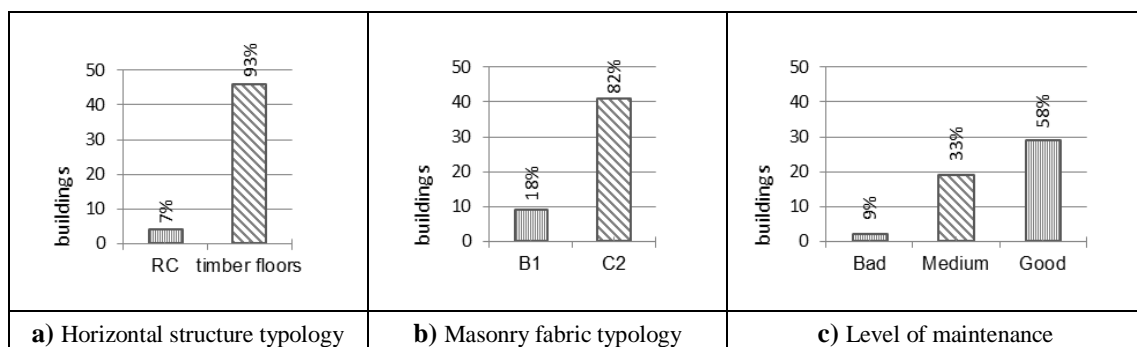
Sample characteristics regarding horizontal structure typology, masonry fabric typology and level of maintenance in percentages are shown in figure 15. The percentage of façades with bad level of maintenance is very low because, according to the selection criteria mentioned in this section, ruined buildings have not been included in the sample.

Fig. 15 Sample characteristics in percentages: **a)** Horizontal structure typology (RC: RC floors and timber floors: traditional timber beams and joists with lightweight vaults floors), **b)** masonry fabric typology (B1: kiln brickwork and C2: poor quality rubble stone, according to FaMIVE description) and **c)** level of maintenance (bad, medium and good)
