# Exposure Factors Influence Stone Deterioration by Crystallization of Soluble Salts

To perform this studio we focus on the stone obtained from the Church of *Santos Juanes* in Valencia. The Church of *Santos Juanes* is situated, within its enclave, in the historic centre of Valencia, in an area delimited by and known as the *Barrio del Mercat* (market neighborhood). The group of dwellings in this quarter, as with many others that form part of the city, are characterized by belonging to, and forming part of, the urban history of the city of Valencia [1].

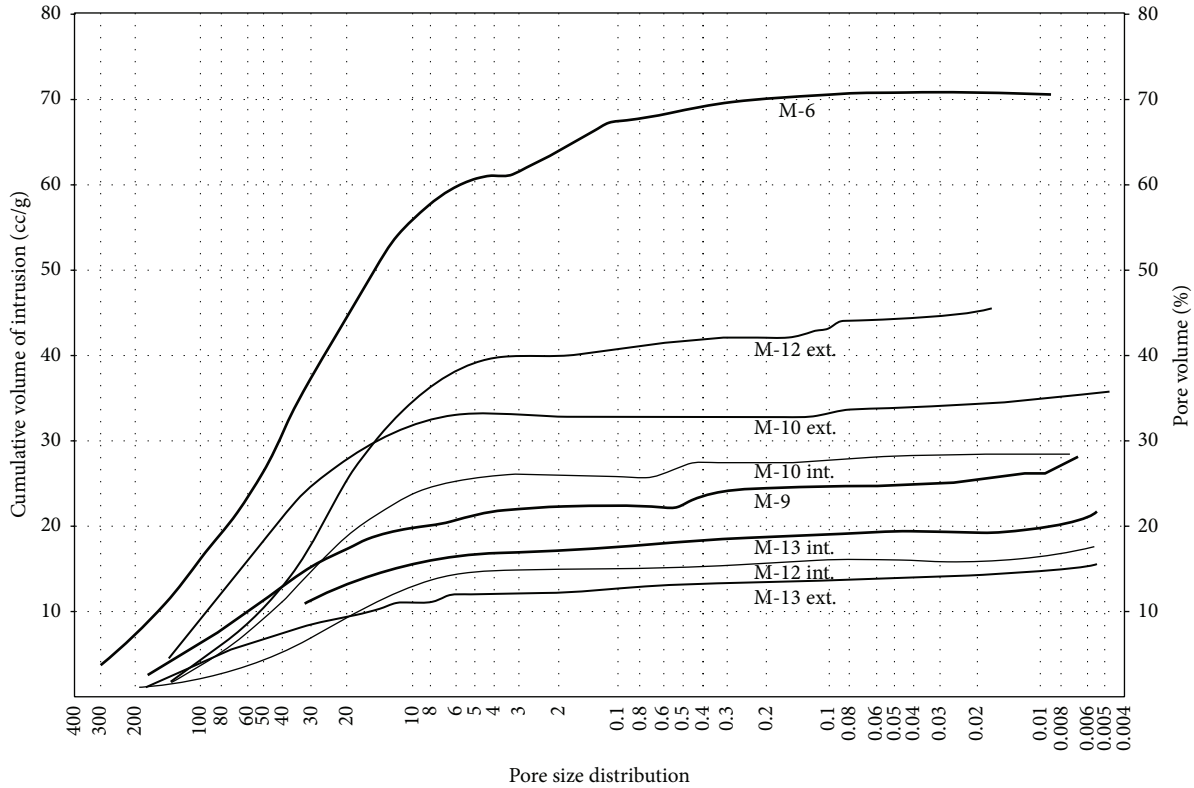
FIGURE 3: Graphical representation of pore diameter.

Figure 3 shows the main samples M-9, M-13, and M-12 correspond to parts of the building that historically belong to the second most important building period of the temple. The values are similar when comparing the volume of open

M-12 has a bigger increase in the volume of pores but shows the same size of average diameter of the pores. M-13 has a significantly lower volume increase of open pores from the internal to the external parts and indeed the average diameter of the pores is bigger in the internal part of the sample. We should remember that the sample corresponds to the high part of the building looking on to *Vieja de la Paja* street, covered by a calcium sulfate crust which seals the surface, as well as the carbonate which has accumulated in the pores causing the surface to stagnate, as we can observe in Figure 6(c), all of which can cause the reduction of the average pores radius.

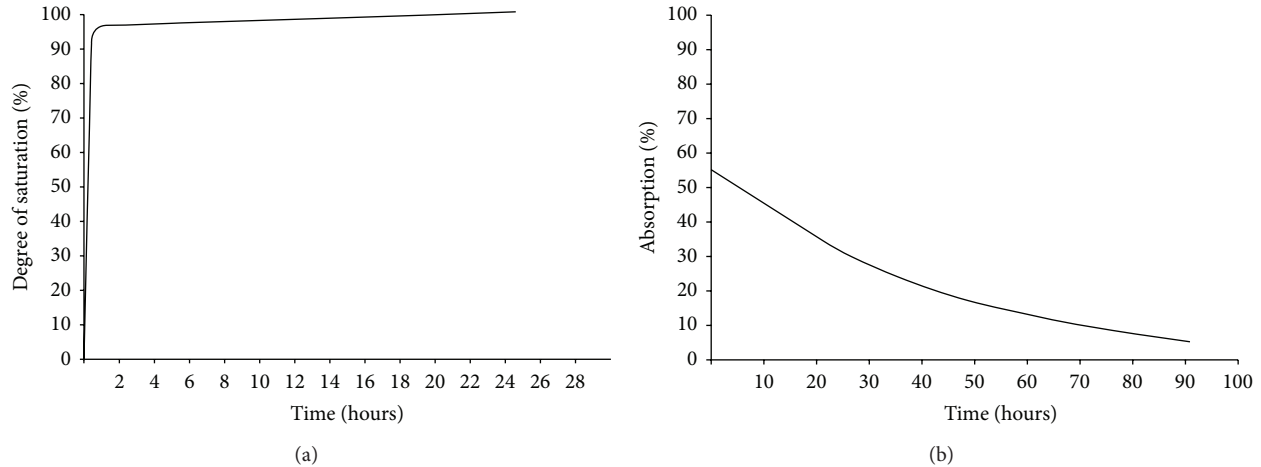
FIGURE 4: Absorption (a) and desorption (b) curves.

We also checked the water saturation and effusion capacity of the material, plotting their corresponding curves, which confirm that we are dealing with a highly porous rock and that the drying of the surface is slow and diffuse caused by the flow of water to its interior (Figure 4). The stone has high connectivity and variations in pore size or interpore connections. The absorption curves for these rocks could be broken down into two straight lines exhibiting a gradual change of slope between the initial and final phase [10].

desorption curve (Figure 4) showed that rock underwent slow, on the whole, evaporation where moisture was retained inside the pore system longer. Salts crystallization can occur if the solution is saturated or supersaturated [5]; therefore, it is possible that the concentration is constant and the temperature decreases, the solution reaches the saturation condition, and a low crystallization occurs. If evaporation occurs at a constant temperature, the concentration of the solution increases rapidly at the end of the capillaries and saturation is reached. The most common is that the combination of decreased temperature and increased concentration of the solution occur simultaneously.
