Axially loaded RC columns repaired on one side with cement-based mortars

A.Irene Ortega, Teresa M. Pellicer, Pedro A. Calderón, Jose M. Adam*

Abstract

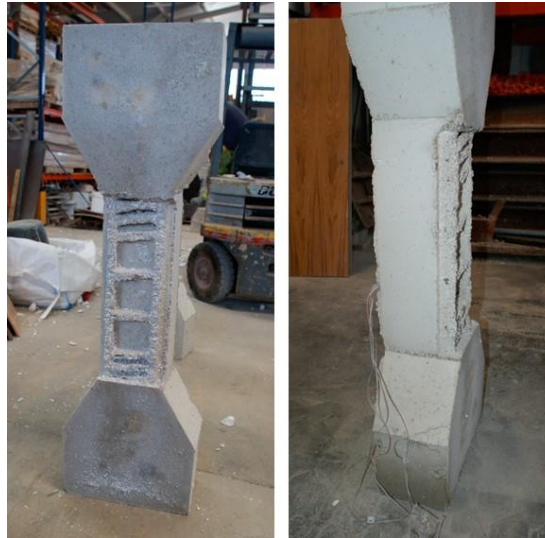
Fig. 2. Damaged Column before being repaired

The compressive strength of the concrete used in the columns was 9.21 MPa to simulate the type used in typical 40 to 50 year old buildings [7,8,10,29]. The columns were poured in a horizontal position to facilitate execution and simulate damage. Damage was simulated by making cavities in the column formwork with 5 cm thick expanded polystyrene (EPS) plates of the “damaged” side of the columns (Fig.1b). These surfaces were roughened and then washed by high-pressure hose to remove any remnants of EPS and prepare the surface for the application of the repair materials. Fig. 2 shows a damaged column before being repaired.

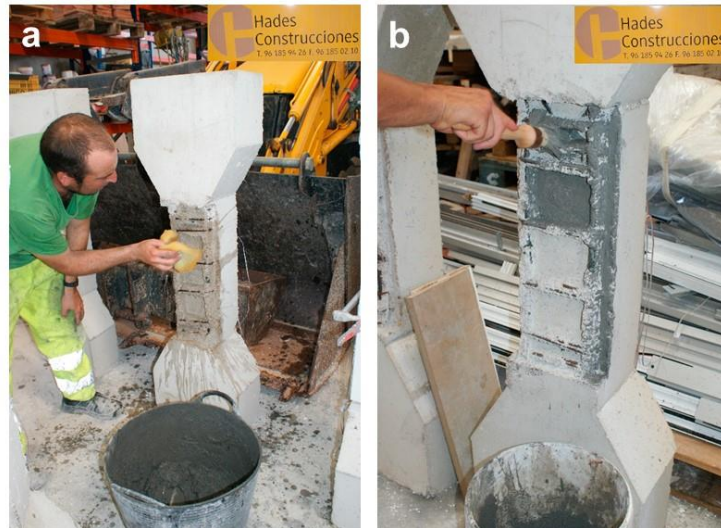
Fig. 3. a) Dampening the surfaces; b) Applying the binder.

- In the columns with no binder, the surface was dampened before applying the first coat of mortar to a thickness of approximately 20 mm to fill any small irregularities. This was allowed to harden slightly, after which the remaining mortar was applied.
- In those repaired with a binder, this was first brushed on immediately before applying the first layer of repair mortar (Fig.3) to approximately 20 mm (Fig.4a), after which the procedure followed was exactly the same as before. The characteristics of the binder can be seen in Table 4.

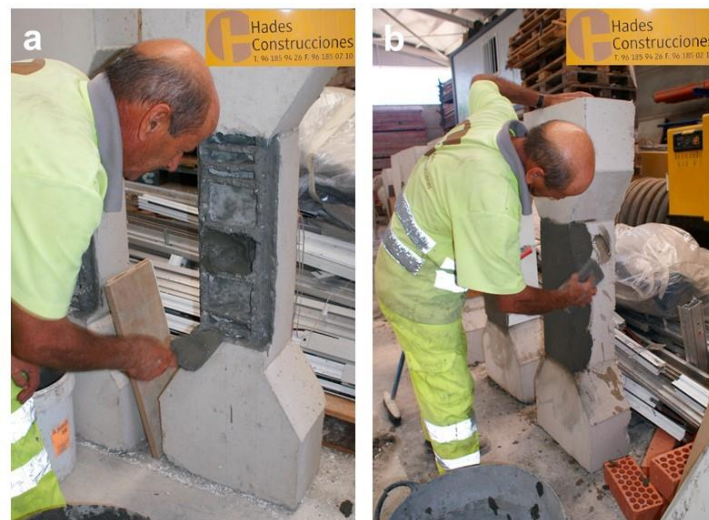
Fig. 4. a) Placing the first layer of the repair mortar; b) Smoothing the surface.

In both cases the surfaces were smoothed after applying the mortar to achieve a better finish (Fig.4b).

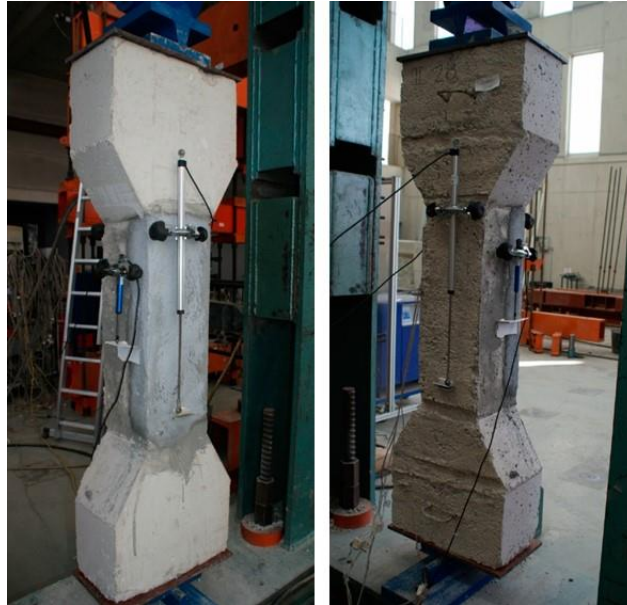
Fig. 5. Instrumentation

Strain gauges were fitted to the four longitudinal reinforcement bars of the specimens. Displacement sensors were placed on the repaired surface and its opposite surface, in contact

with the repair mortar and the concrete, respectively, also on one of the other sides of the column to measure the relative displacement of the concrete and mortar (Fig.5). The columns were tested under vertical compressive load by means of a 2,500 kN hydraulic jack.

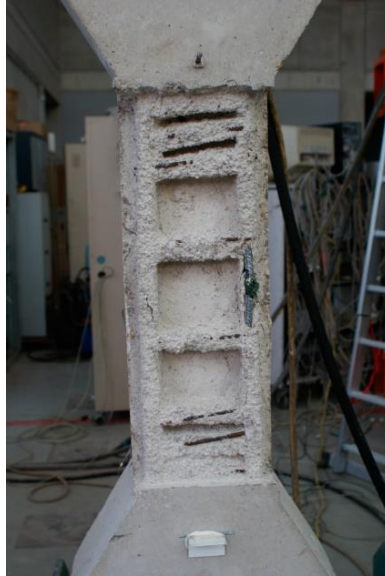
Fig. 6. Failure pattern in specimen D (damaged unrepaired columns). Buckling in rebars in side 3.

The undamaged columns (U) showed typical compression failure with vertical cracks on the sides. The damaged unrepaired columns (D) failed by eccentric compressive loads due to the asymmetry of the cross section caused by the damage to one side, which buckled the longitudinal reinforcement on the damaged side (Fig.6), while the opposite side presented horizontal cracking which spread to the lateral surfaces.

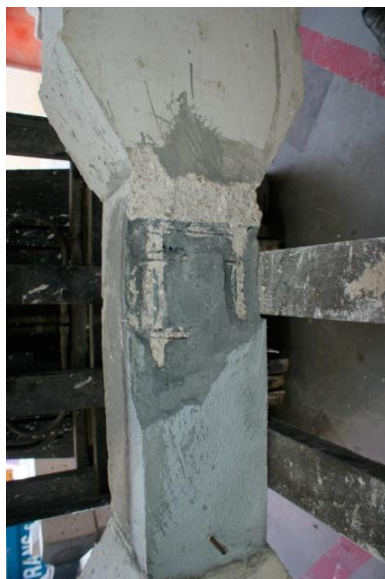
Fig. 7. Failure pattern in Specimen B3. Detachment of a mortar layer

- a) The columns repaired with Class 3 mortar and binder (B3) had a slight horizontal crack halfway up the intact side (Side 1) which spread to both lateral sides. The damaged and repaired side (Side 3) showed vertical cracking at a third of its height, while the horizontal crack on Side 1 was seen to slightly affect the sides. A vertical “cold joint” was seen to appear between the repair mortar and the specimen’s original concrete. The detached repair mortar after the test can be seen in Fig. 7.

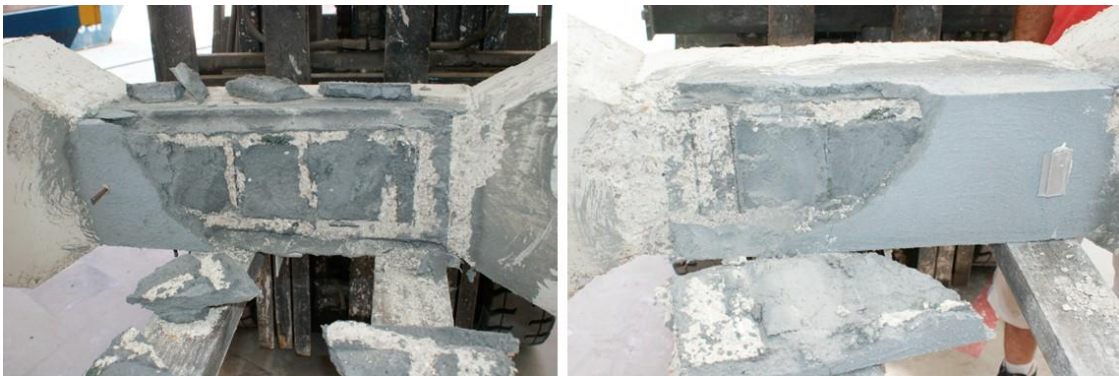
Fig. 11. Failure patterns in specimen B4. Detachment of a mortar layer

can be seen that caused the repair layer to come detached to a thickness of approximately 1.5 cm (Fig. 11).
