# Flood Risk in a Heritage City: Alzira as a Case Study

**Abstract:** Floods are natural hazards which have damaged cities and their architectural heritage over the centuries. The heritage town of Alzira (Valencia, Spain) is a major case study for the assessment of flood risk in architectural heritage. Alzira was founded by the Al-Andalus Moors on a river island within a bend of the river Júcar, which has overflowed more than 80 times during its history. The main aim of this work is to analyse the vulnerability to floods of the town's architectural heritage, especially that of earthen architecture, a constructive tradition of which several examples can be found in the town. The proposed methodology attempts to calculate the vulnerability of the earthen architecture through the evaluation and weighting of extrinsic and intrinsic parameters. This makes it possible to identify the constructive characteristics and material weathering which worsen the behaviour of structures during floods. Maximum vulnerability values have been obtained for poorly conserved constructions without cladding. Results highlight the importance of ascertaining suitable strategies for the prevention and mitiga

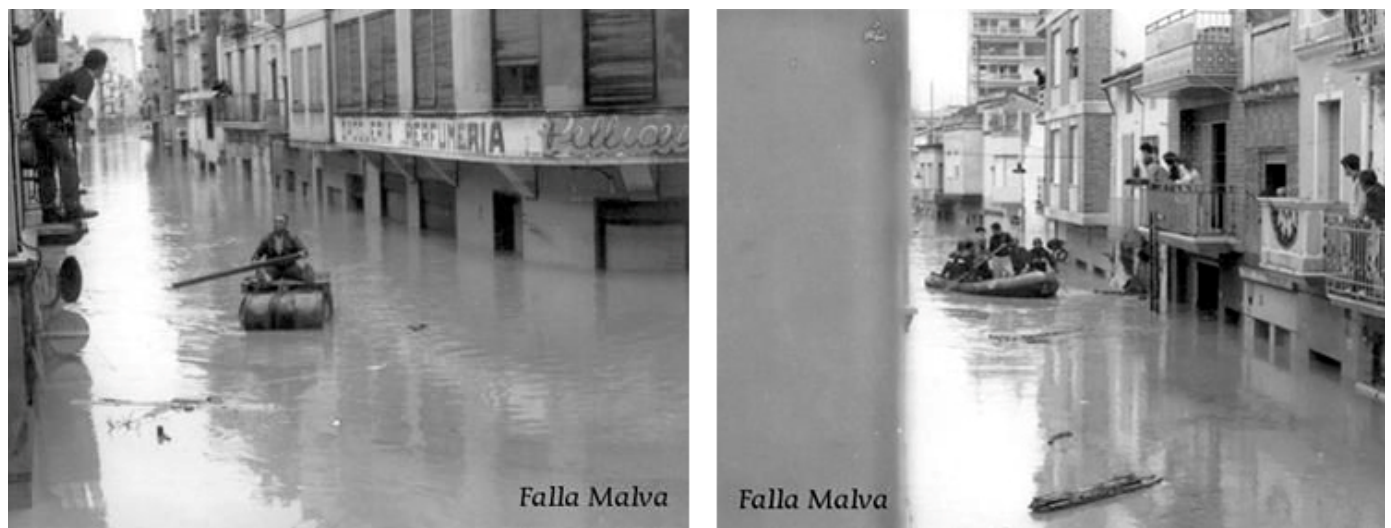
**Figure 1.** Alzira. Flood of 20 October 1982. Source: <http://www.fallamalva.com> (accessed on 30 May 2020).

The first known flood dates back to the year 1320. Since then, there have been over 80 floods, most notably the 1743 flood which destroyed 900 homes [7]. In 1573 the city was under threat on several occasions while the year 1590 is remembered as the “year of floods”, with 22 floods [19,20]. There were many major floods in the following centuries and in 1805 two major floods caused water levels to rise up to two metres, seriously damaging the city [21]. However, the flood of 4 November 1864 was one of the most severe. After the flood a report was drafted for the Ministry for Development by the Inspector General of Engineers and Chief of the Commission for Overflowing of the Júcar, M. Bosch y Juliá. In the report Bosch refers to the extraordinary high-water levels reached [22] and provides data on the damage. In the town centre 100 homes were destroyed, 331 half-submerged, 203 showed major damage, and 50 were at risk of ruin [7]. Following this flood several strategies were drawn up to prevent and mitigate flood risks in Alzira. One of these was Bosch’s proposal to correct the course of the river Júcar, cutting off the channel on the right and filling up the ditch. An initial phase of the project to change the course of the river Júcar, drafted by the engineer Enrique González Granda and passed in 1909, was completed in the 1920s and 1930s [23]. This project closed off the right channel of the river with a masonry-clad earthen dam 10 metres high [23]. The data from the 1869 flood were also used to design a dam near the town of Tous (Valencia), where a maximum (peak) flow of 6000 m<sup>3</sup>/s had been recorded [24]. Unfortunately, the flow used in the design of the size of the Tous dam was much lower than that recorded on 20 October 1982. After heavy rain the input hydrograph in Tous recorded a maximum flow of 10,400 m<sup>3</sup>/s and a total volume received of 867 hm<sup>3</sup>, almost 17 times higher than the capacity of the design. The power cuts caused by the heavy rain prevented the floodgates from opening so that the level of the water from the rivers Júcar and Escalona caused the dam to overflow, breaking the central sector and submerging Alzira in over 2 metres of water and mud (Figure 1).

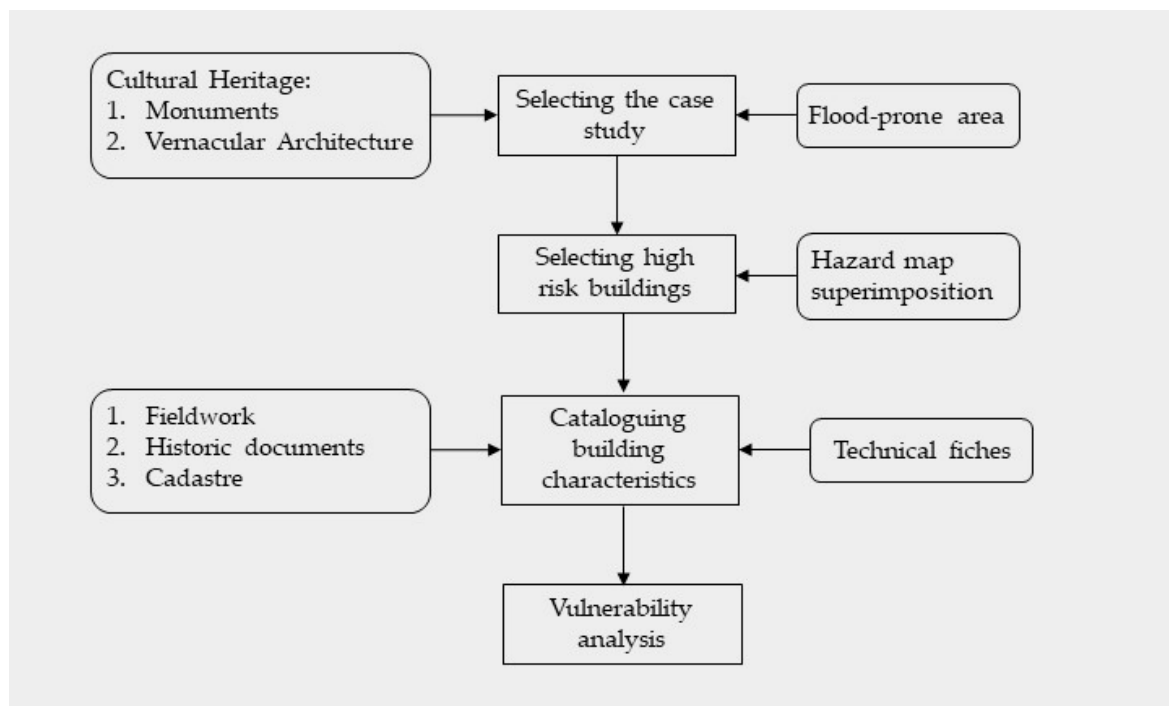
Figure 5. Methodological map.

The methodology proposed for the assessment of the vulnerability of heritage earthen architecture in the event of floods was organized into phases (Figure 5), compiling, analysing, and contrasting data [35–37].

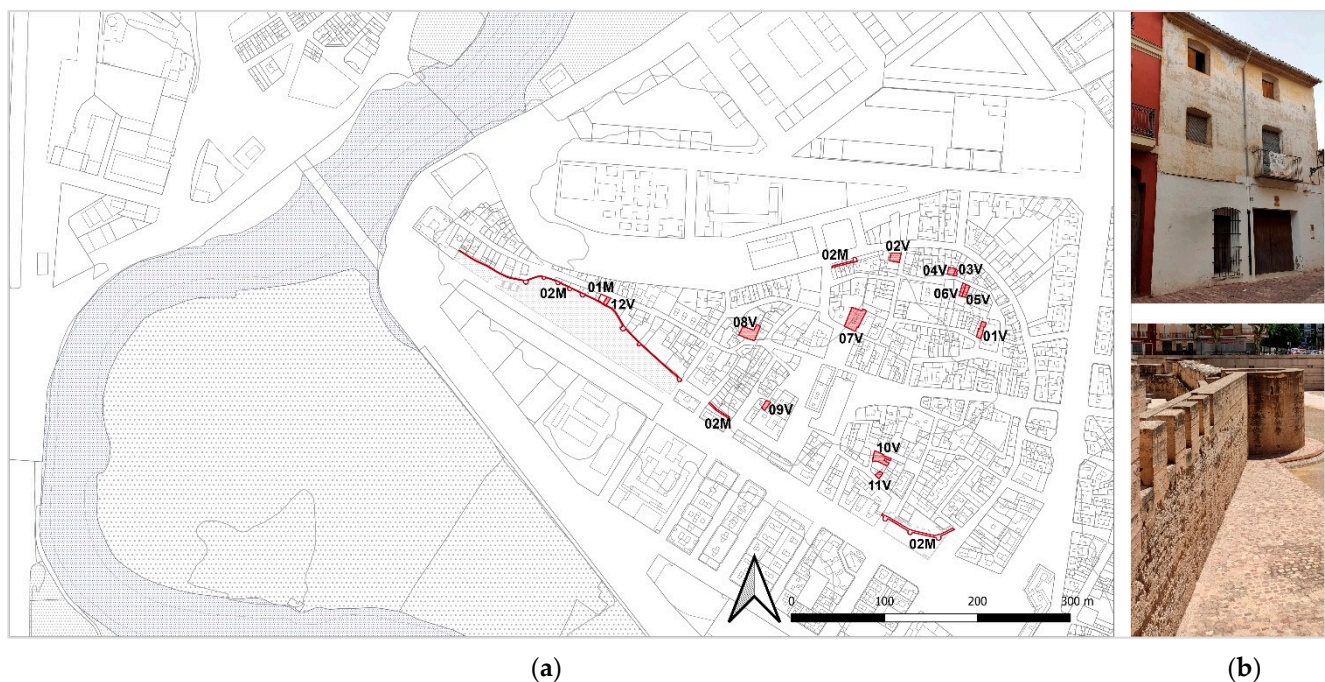
**Figure 6.** (a) Map of the Vila de Alzira. Case study locations. (b) Two heritage buildings: 07V (above) and 02M (below).

Several resources were used to select buildings. Fieldwork was used to carry out an initial selection of buildings which was subsequently reviewed using historic documents and documents from the cadastre and the Special Protection Plan of the Vila de Alzira [38]. This information was contrasted with that provided by the MUMA museum (Museo Municipal de Alzira), identifying 12 vernacular heritage dwellings and 2 examples of monumental architecture (Table 2; Figure 6).

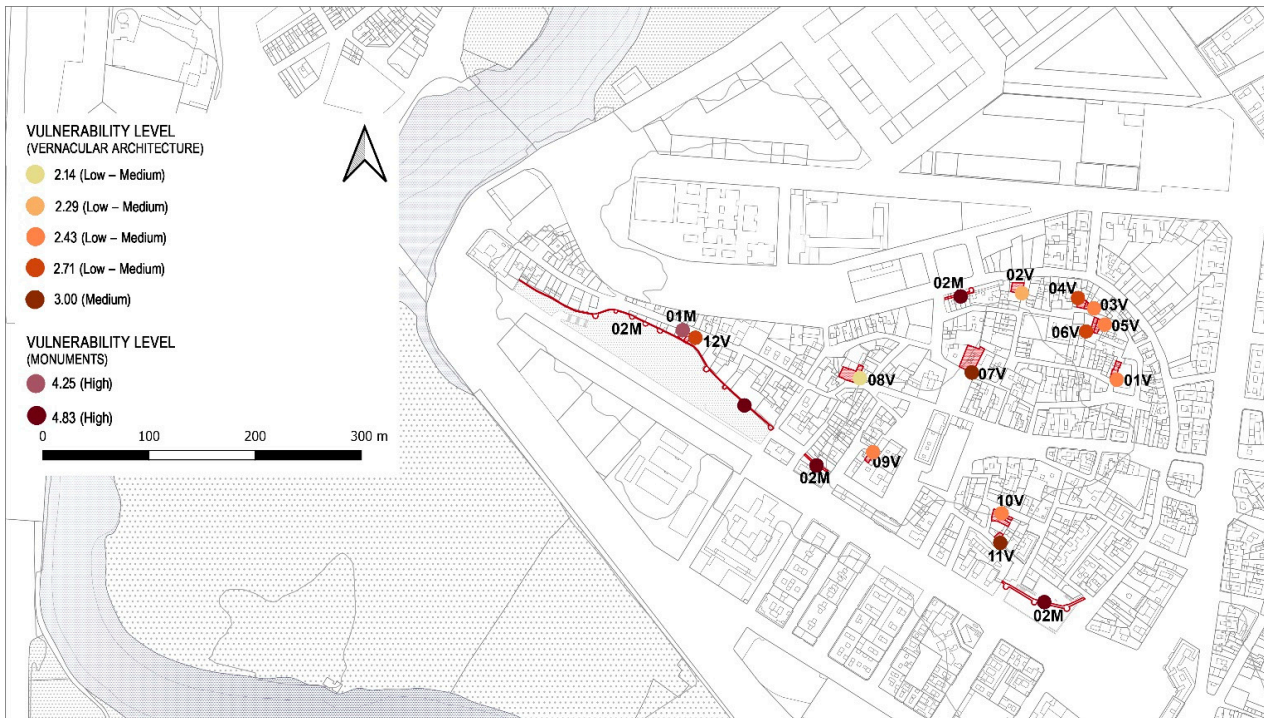
Figure 8. Building vulnerability map.

Following data collection, the vulnerability value of individual case studies was calculated (Table 8), obtaining values of 2.14–3.00 for vernacular architecture and of 4.25–4.83 for monumental architecture (Figure 8).
