Ortega, I.; Pellicer, TM.; Adam, JM.; Calderón García, PA. (2018). An experimental study on RC columns repaired on all four sides with cementitious mortars. *Construction and Building Materials*. 161:53-62. doi:10.1016/j.conbuildmat.2017.11.126

Experimental testing on axially loaded RC columns repaired on all four sides with cementitious mortars

Keywords: *Column, Repair, Reinforced Concrete, Building, Experimental, Mortar*

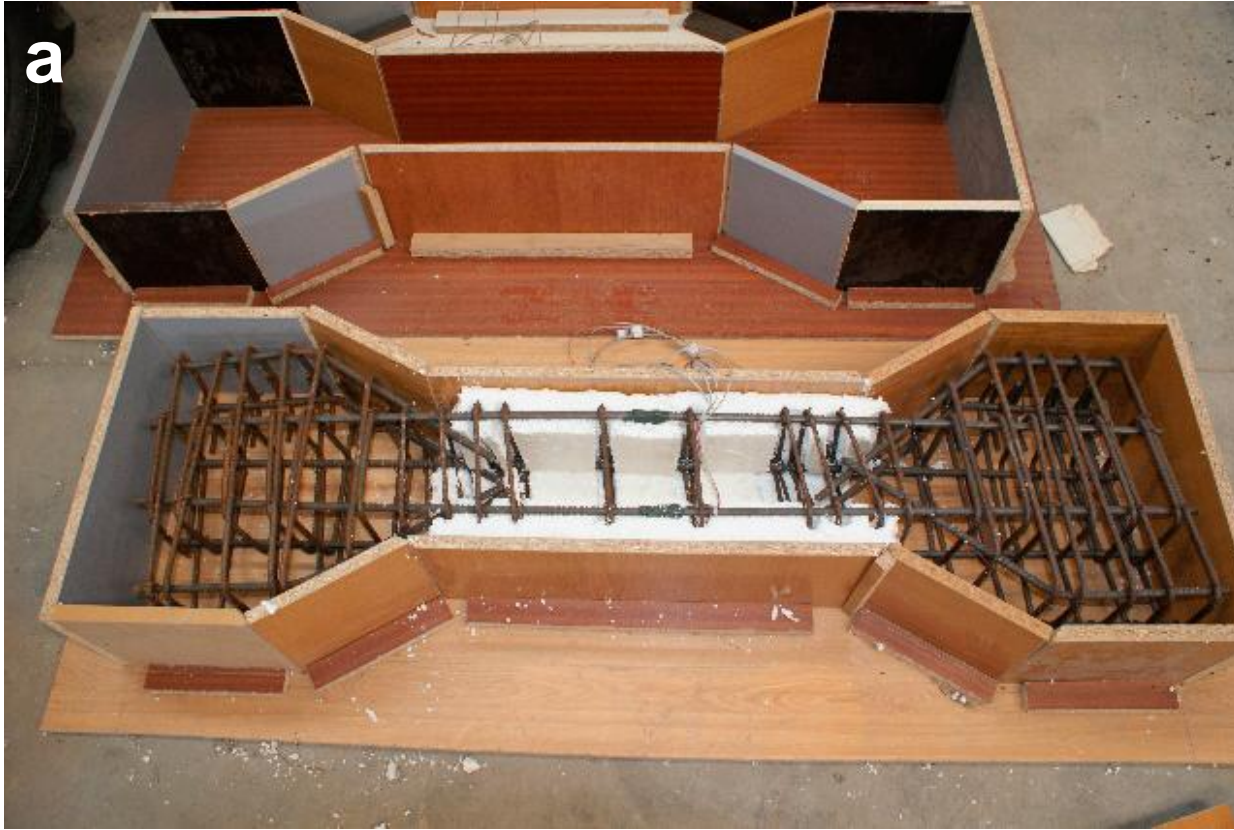
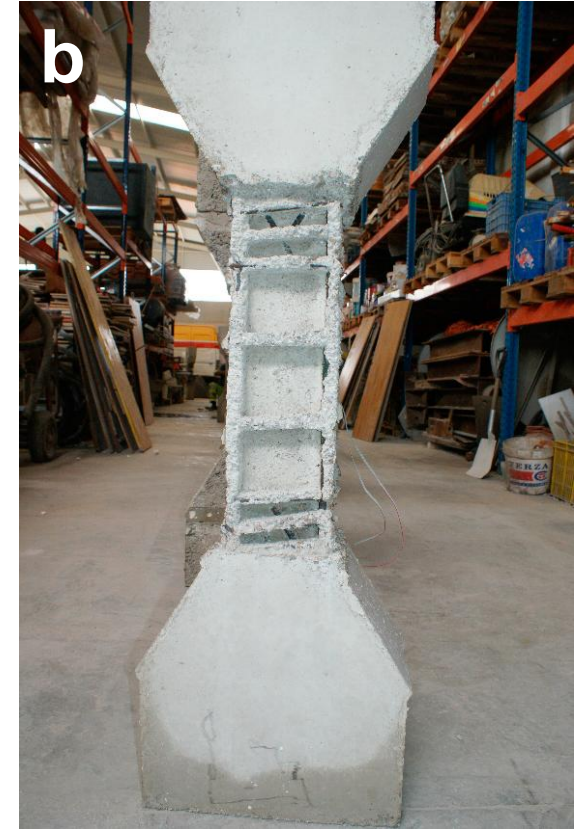
Fig. 2. a) Specimen contained by formwork; b) Damaged Column (DC) before repair.

Damage requiring repair was simulated in 15 columns, while three were left untouched (Control Columns). The damage was simulated by using expanded polystyrene (EPS) placed in the formwork before pouring to create hollows (see Fig. 2). The “damaged” columns were

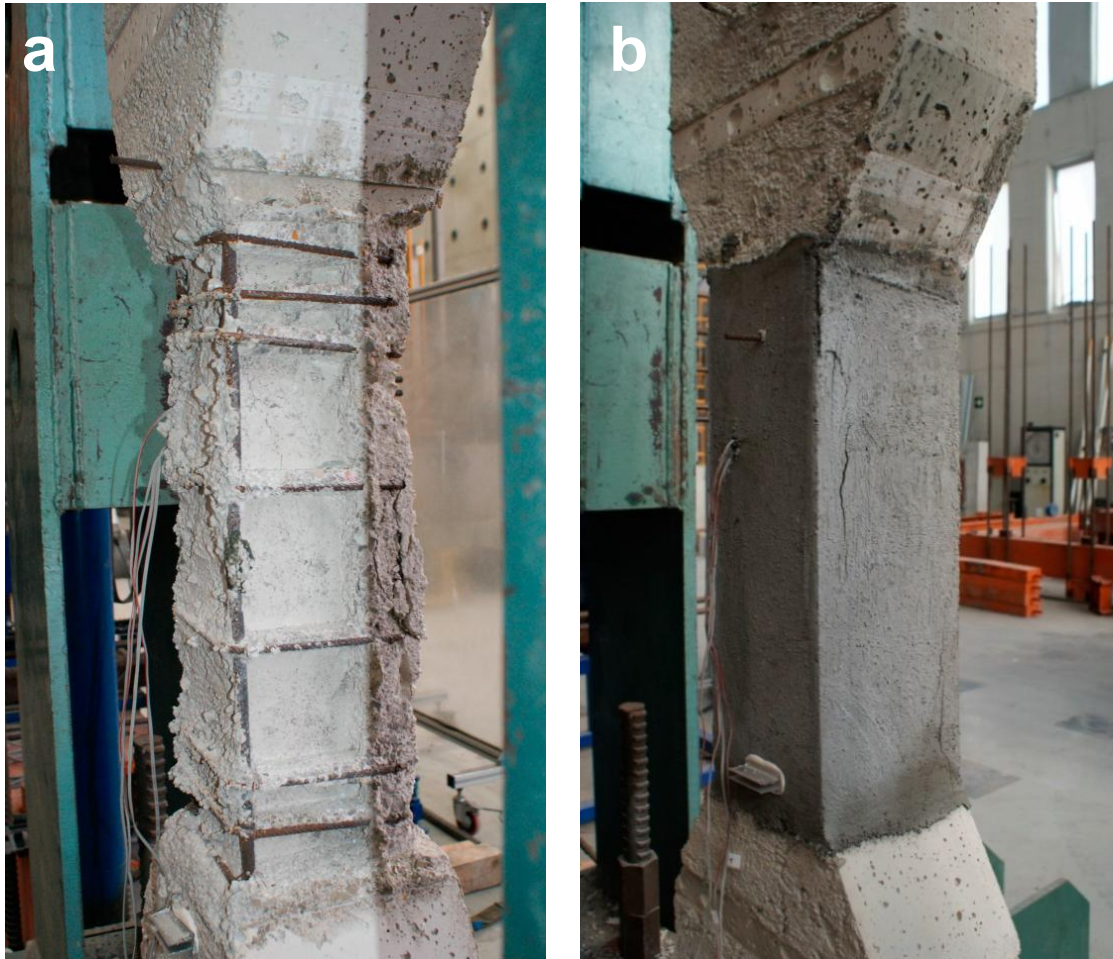
Fig. 5. a) Damaged column (DC); b) Failure mode: Specimen R3B (repaired column with Class R3 mortar with bonding agent).

- a) Repaired columns with Class R3 mortar and bonding agent (R3B, Fig. 5.b). The vertical cracks can be seen typical of the dry joint due to the repair being made in two phases. Smaller cracks can also be seen coinciding with the reinforcement on the sides with no dry joint and the bonding between the repair mortar and concrete can be seen to be adequate.
- b) Repaired columns with Class R3 mortar without bonding agent (R3, Fig. 6.a). The failure mode is similar to the R3B (Class 3 mortar with bonding agent) with vertical cracks identifying the dry joints. However, here the mortar became completely separated from the sides to which mortar was applied in the second phase (Fig. 6.b), which did not happen in the previous case.
