Cement-based mortar patch repair of RC columns.

Comparison with all-four-sides and one-side repair

A. Irene Ortega, Teresa M. Pellicer, Pedro A. Calderón, Jose M. Adam *

This paper describes an experimental study on patch-repaired reinforced concrete columns subjected to axial loads until failure. The behaviour of four series of columns repaired with Class R3 and R4 cement-based mortar was analysed both with and without a bonding agent. The results obtained were compared with control series of undamaged and damaged but unrepaired columns to determine the effectiveness of the repairs and the subsequent improvement in the behaviour of the columns. The results of this study were compared with those of previous work by the authors on the analysis of all-four-side repairs and one-side repairs. The conclusion reached was that patch repairs are highly effective as compared to the other techniques studied and that using Class R3 mortar achieves better results on damaged columns made with low-quality concrete. It was also concluded that applying a bonding agent does not improve the results, although this element was found to be necessary to prevent the premature detachment of the repair

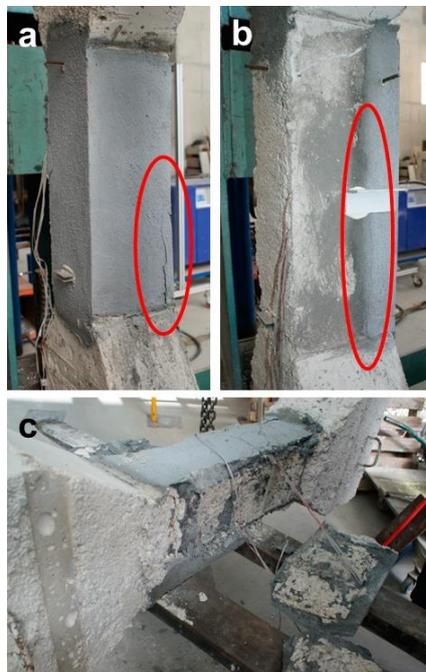
Fig. 2. Column failure through the dry joints: a) Specimen F4W (all-four-sides repaired with R4-mortar and no BA); b) Specimen O3B (one-side repaired with R3-mortar and BA); c) Specimen F3B (all-four-sides repaired with R4-mortar and BA), detachment of the repair

In both repair methods failure was due to the detachment of the RM from the dry joints, as can be seen in the different series of specimens shown in Fig. 2. This detachment produced asymmetric loads on the cross section which generated eccentric compression on the column and caused it to fail.

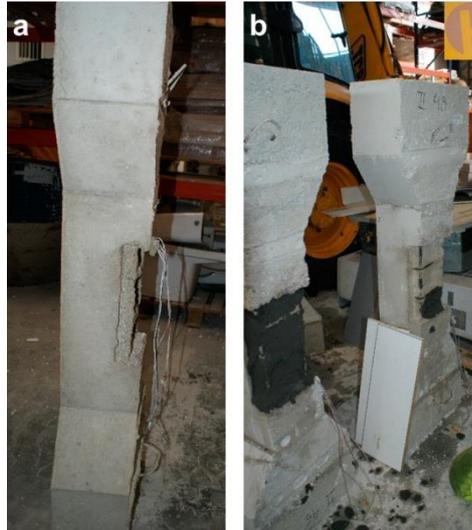
Fig. 4. a) Detail of the column hollow to perform the patching repair; b) Filling the first layer of column patching

As in the preceding one and four-side tests, the surfaces were wirebrushed and washed with a pressure hose to eliminate all traces of EPS before applying the same RM as before (Table 2), two layers of which were applied with a trowel (Fig. 4).

As in the previous tests, for repairs without BA the procedure was as follows: the first layer of approximately 20 mm of RM was applied to the wet surface, filling the spaces between the column concrete and the reinforcement. This was followed by a further layer to give a total thickness of 50 mm. In those with BA, the surfaces were first impregnated with the product just before applying two layers of mortar, as before. When this was dry, the surface was smoothed to obtain a better finish.

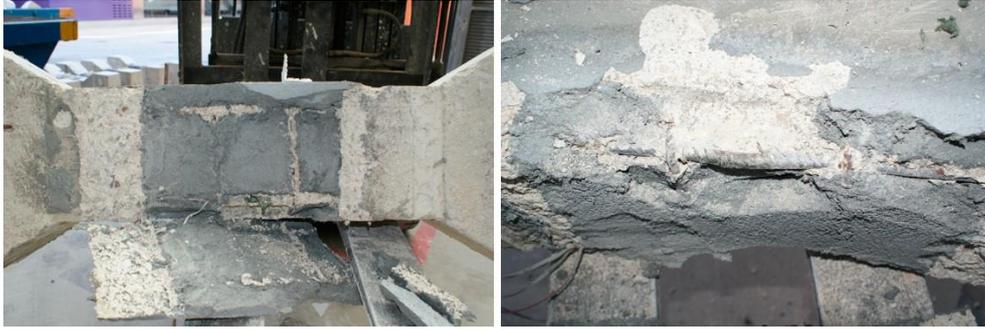
Fig. 11. Column failure: Specimen P4W (repaired column with R4-mortar and no BA). Detail of the detachment of the patch

d) Specimens repaired with R4-mortar and no BA (P4W, Fig. 12d): as in the previous series, repair failure was due to detachment of the RM (Fig. 11). The loss of the bond between the RM and concrete can be seen; this was found to be due to RM detachment and the tensile cracks on Side 3 on reaching 95% of maximum load. Repair effectiveness was 87% of that of the undamaged control column, while the improvement over the unrepaired damaged column was 125%, the lowest values of all the series, indicating that the repairs contributed least to the improvement and that this combination is the least appropriate of the four cases studied. In this case the ultimate strength of the columns repaired without BA is 9% lower than those repaired with BA, unlike the series repaired with R3-mortar. This is due to the fact that the excessive stiffness of the R4, which causes the RM to detach, can be offset by using a BA to improve the bond between both materials. All the indicators studied show that that this type of repair is the least appropriate for patch repairs on columns with poor quality concrete, due to the difference in stiffness between the R4 and the concrete. The results in this case therefore depend largely on the characteristics of the concrete in the columns, i.e. on the relationship between the stiffness of the RM and the concrete. The closer their elastic moduli are to each other, the less the eccentricity produced and the higher the quality of the repairs.
