An Experimental and Numerical Investigation to Characterize an Aerospace Composite Material with Open-Hole Using Non-Destructive Techniques

Abstract: In this study, the open-hole quasi-static tensile and fatigue loading behavior of a multidirectional CFRP thick laminate, representative of laminates used in the aerospace industry, is studied. Non-destructive techniques such as infrared thermographic (IRT) and digital image correlation (DIC) are used to analyze the behavior of this material. We aim at characterizing the influence of the manufacturing defects and the stress concentrator through the temperature variation and strain distribution during fatigue and quasi-static tests. On the one hand, the fatigue specimens were tested in two main perpendicular directions of the laminate. The results revealed that manufacturing defects such as fiber waviness can have a major impact than open-hole stress concentrator on raising the material temperature and causing fracture. In addition, the number of plies with fibers oriented in the load direction can drastically reduce the temperature increment in the laminate. On the other hand, the quasi-static tensile tests showed that the strain dis

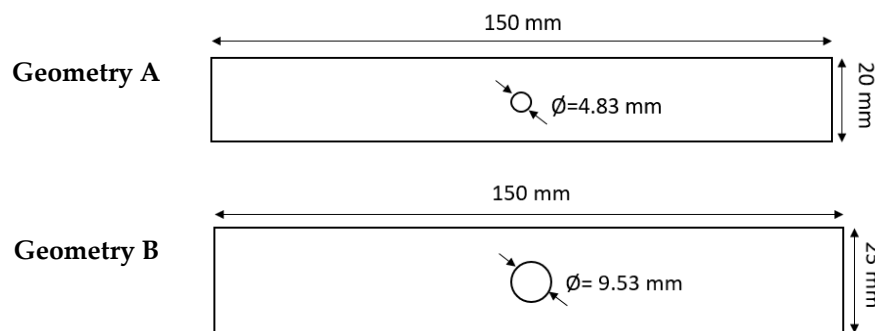
Figure 1. Geometries of the CFRP specimens. Samples of each geometry were cut considering both the longitudinal and transverse directions of the original laminate plate.

Two different geometries are used in the study, depicted in Figure 1. Samples of these geometries were prepared for both the longitudinal and transverse direction of the original laminate plate material. The hole and the external perimeter were cut using an abrasive waterjet cutting technique.

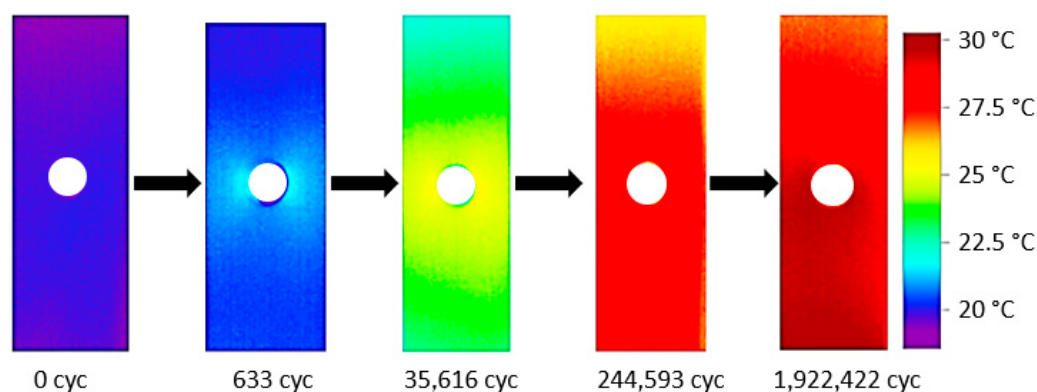
Figure 3. Example of the surface temperature evolution during fatigue test.

This part of the study was carried out using specimens oriented in longitudinal and transversal orientations of the original laminate plate material. The fatigue tests were performed under load control mode with a $\sigma_{\max} = 60$ kN, a $\sigma_{\min} = 0$ kN and a frequency of 10 Hz to minimize non-adiabatic effect and reduce testing time [64]. The limit of cycles was established at 2 million. Figure 3 shows an example of the temperature variation measurement in a longitudinal specimen during fatigue testing with the geometry A.

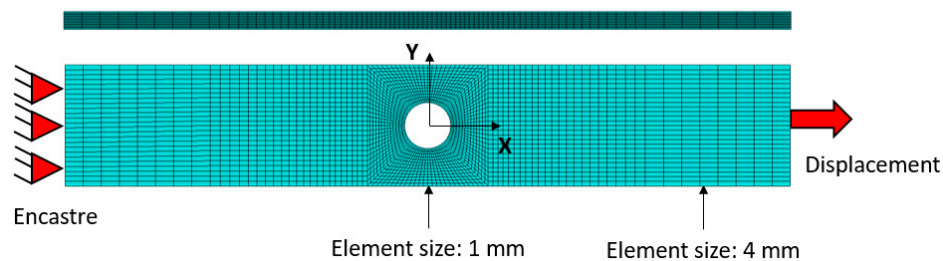
Figure 6. Representation of the finite element model generated considering the test conditions. A high level of discretization was defined at the stress concentration region.

Finite element models of each configuration were developed using ABAQUS/Standard code, aimed at simulating the quasi-static tests described previously. Each model reproduces the multidirectional carbon fiber component described earlier. The laminate is implemented with 3D solid elements C3D8R (8 node-linear brick, reduced integration and hourglass control), with a size of 1 mm close to the hole zone and 4 mm far from this area. One element per ply is defined through the thickness. The symmetry plane in the stacking sequence is considered, hence only half of the laminate is defined (27 plies) to save computational time. The displacement of the workpiece is restricted at one side and a fixed velocity of 2 mm/min is applied to the opposite side simulating the same experimental conditions. All the layers are tied. The scheme of the full model, including boundary conditions, is presented in Figure 6.

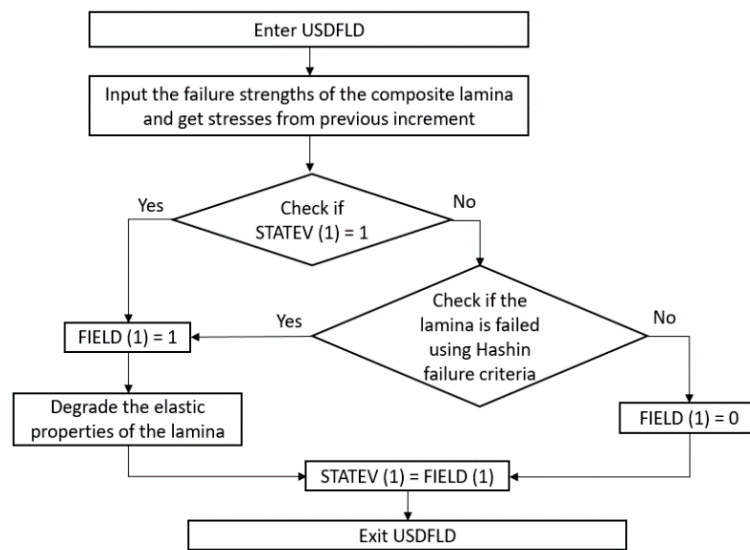
Figure 7. Flowchart of the Progressive Damage Model implemented in the Abaqus user subroutine USDFLD.

The plies have been modeled assuming an elastic behavior until failure due to their high strength. The failure of the plies has been defined using the Hashin criterion [69], which considers matrix cracking (traction failure mode Equation (2) and compression failure mode Equation (3)), fiber breakage in tension—Equation (4)—and fiber micro-buckling in compression—Equation (5). In these equations, capitalized magnitudes refer to the corresponding failure strengths. The damage behavior has been implemented using an Abaqus user subroutine USDFLD, which follows the flowchart in Figure 7.

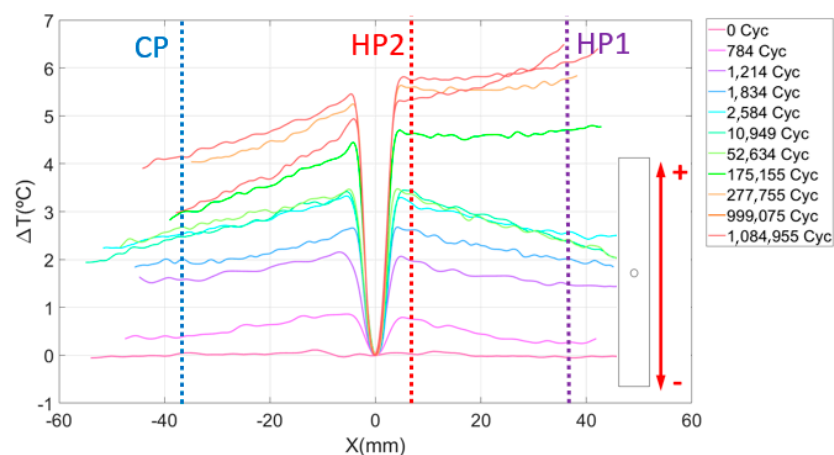
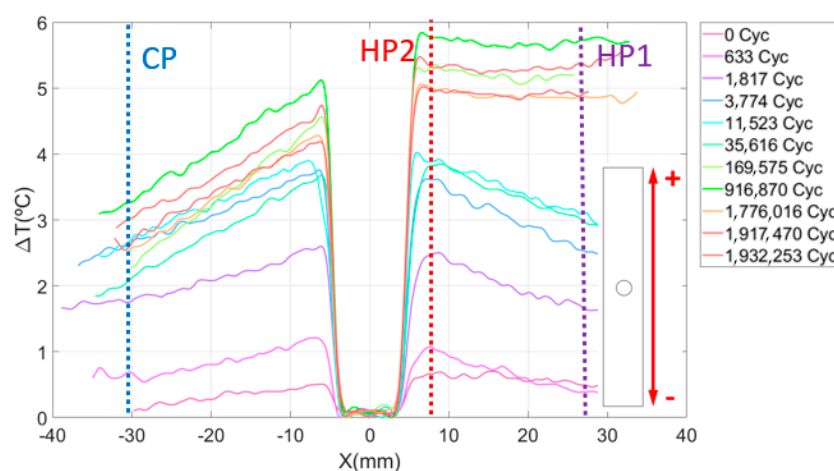
Figure 11. Evolution of the surface temperature variation as function of the number of load cycles in specimens cut at transversal direction for (a) geometry A and (b) geometry B.

For the specimens cut in perpendicular direction to the plies at 0° , the damage initiation and progression scheme was similar to the previous samples. The results for these configurations are presented in Figure 11. In this case, none of the tests reached breakage because the number of plies oriented in the load direction is greater than the number of plies oriented at 0° , which increases the laminate resistance. For the same reason, the surface temperature increment is lower than the one detected in the previous specimens cut in longitudinal direction to the plate. In both cases, the load amplitude was kept, and the cycle limit was fixed at 2,000,000. Nonetheless, it is easy to identify the areas where the specimen presents defects because the surface temperature starts to increase faster than in other laminate areas. In addition, we can see that, by increasing the number of plies oriented in the traction direction, the presence of damage caused by waviness is delayed with the number of cycles.

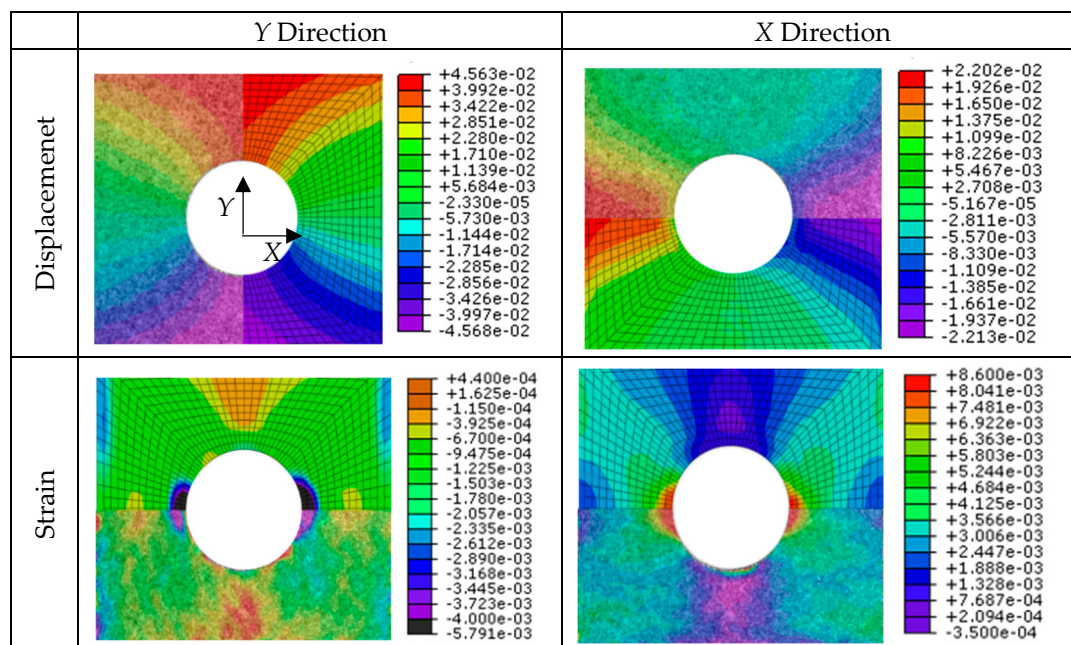
**Figure 14.** Comparison of displacement and strain field between DIC estimation and numerical prediction for geometry B.

On the other hand, two finite element models that reproduce the static tensile testing were developed. They were validated against the experimental predictions of DIC technique. Specifically, both the displacement and strain fields have been compared for geometry A (Figure 13) and geometry B (Figure 14) configurations. It can be observed that the distribution of the field is very similar for both cases and in both directions, which validates the numerical models developed and points out the effectiveness of DIC technique for surface displacement analysis.
