Robert College Seismic Upgrade

Anurag JAIN, Matthys LEVY*, Can SIMSIR

Principal, Weidlinger Associates

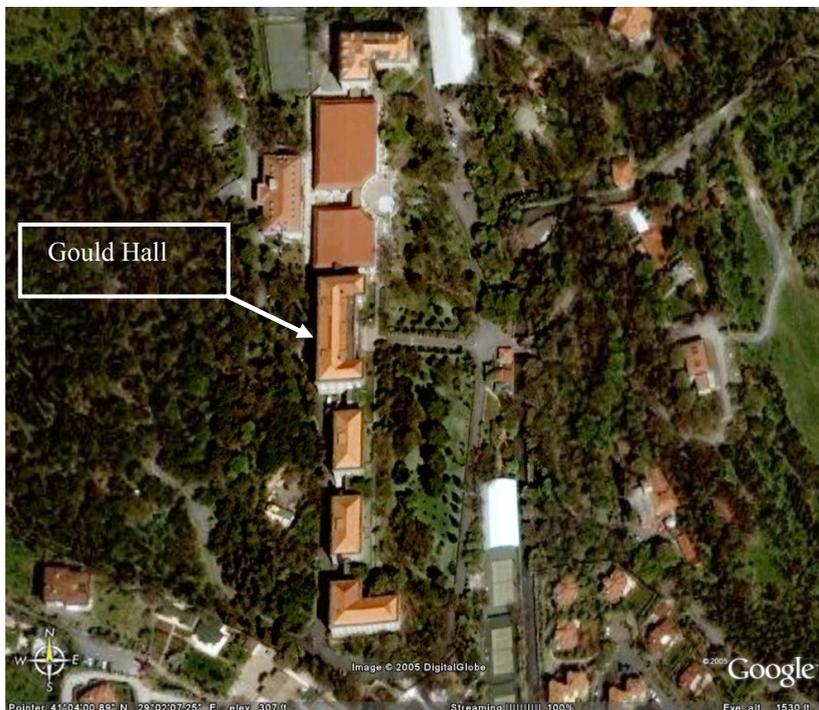
Figure 1

Gould Hall is the fourth building from the South on the North-South row of main College buildings (Fig 1) and is the center piece of Robert College. The building plan is essentially a C-shape with dimensions of 54.0 m by 25.0 m (177' by 82'). The five-story structure has story heights of 4.11 m (13'-6") except for the first story which is 3.50 m (11'-6") tall. The first story is also referred to as the basement in the original design drawings although it is partially above grade. Gould Hall is the heart of the Robert College buildings, the reception point of all – after a set of stairs on the main pedestrian approach. Its colonnaded front forms a welcoming alcove with projecting arms on both sides. An impressive loggia above the main entrance commands a view of the sloping main field and the Bosphorus beyond. It is the largest building of the five originally constructed buildings and the most elaborate. All exterior walls are exposed concrete, *béton brut*. The dominant character of the building finds its reflection in the form of its free standing columns, stairs leading to the entrance, double-story arched openings, and central location.
