Conservation and restoration of timber architecture in the Czech Republic

Martin Cernansky¹

¹National Heritage Institute, Prague, Czech Republic, cernansky.martin@npu.cz

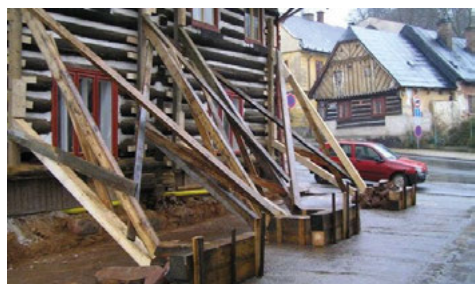
Fig. 1. Façade of the pub “Dřevěnka Inn” No. 92 (house formerly) supported by interim oblique back shores with balk and stone footing that is secured by iron anchor rods in the drilled opening, Úpice Village, Trutnov District, Hradec Králové Region © Martin Cernansky, 2008, NHI

- **supporting** (Fig. 1.,2.)
/ prop, strut, stanchion, shore, etc.
- **wind bracing**
/ diagonal, cross, chevron brace, etc.
- **hanging**
/ webbing, strap, etc.
- **holding together**
/ collar, etc.
- **wedging**
/ joint wedge, etc.
- **covering**
/ canopy, tin hall, etc.

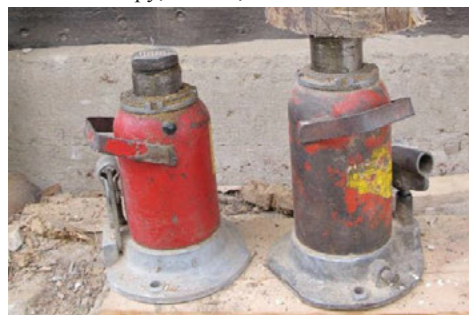
Fig. 2. Watermill No. 2 (82) and intervention requiring the support of the first floor with the aid of hydraulic bottle jack rest on a firm, level surface, Zubrnice Rural Reservation, Ústí nad Labem District, Ústí nad Labem Region © Martin Cernansky, 2015, NHI

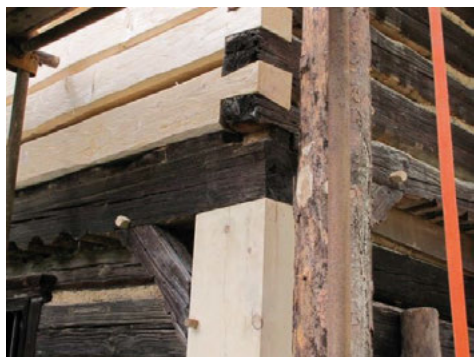
Fig. 3. Watermill No. 2 (82) and new members instead of damaged ones, the replacement requires additional supports and load securing, e. g. by carrying straps/webbing on the right, Zubrnice Rural Reservation, Ústí nad Labem District, Ústí nad Labem Region © Martin Cernansky, 2015, NHI

- **replica, reconstruction**
/ entire structure
- **replacement** (Fig. 3.)
/ just member, element, component
- **enlargement, cross-section**
/ cleat
- **„replenishment“**
/ instead of missing the original member

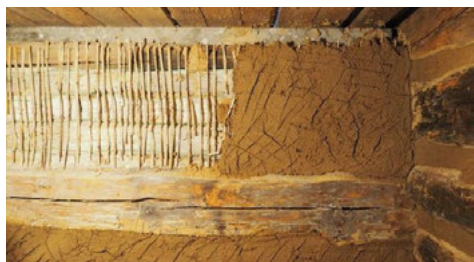
Fig. 4. House No. 14 and mud plaster application on reed mesh, the plaster is coarsened for easy topping coat adhesion as well as prevention of shrinkage cracks, Lhota Rural Reservation, Česká Lípa District, Liberec Region © Martin Cernansky, 2020, NHI

- **daub**
/ thick clay coat, so call “fur” in Czech
- **rendering and plastering** (Fig. 4.)
/ mud plaster, lime plaster
- **cladding**
/ shingles and boards, slates, asbestos-ce-ment slates, metal sheets
- **painting**
/ monochrome, polychrome paint

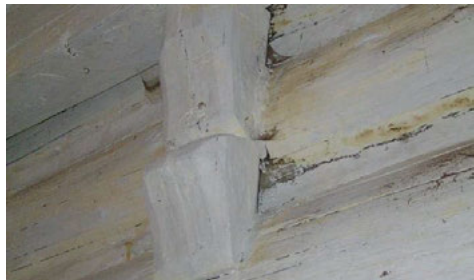
Fig. 5. House No. 53 built of logs used for walls and ceiling. Apart from this profiled bracket, there are also simple shape brackets under the supporting beam. Rtyně v Podkrkonoší Village, Trutnov District, Hradec Králové Region © Martin Cernansky, 2008, NHI

In both cases, it is most often done by the permanent addition of wooden profiles (Fig. 5.) or steel rods. In the second case, only tension load is transferred. Except for the individual structural member (e. g. joist beam), the whole building can be strengthened with a system of support bearing, struts, and/or wind bracing. There are several historical as well as contemporary techniques. Among the historical ones, we can mention especially the ground floor frame of two-storey houses. Brackets supporting a beam placed at the wall are another example of additional and reversible intervention.

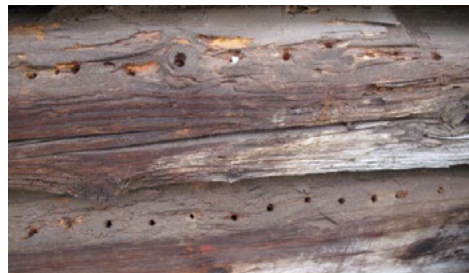
Fig. 6. Watermill No. 2 (82) and improving material properties using resin injection, Zubrnice Rural Reservation, Ústí nad Labem District, Ústí nad Labem Region © Martin Cernansky, 2015, NHI

- **oils**, vegetal and mineral
 - / linseed oil, Tung oil (in Czech later)
 - / used motor oil (until recently, fence)
- **waxes**
 - / beeswax
- **natural resins** (Fig. 6.)
 - / rosin, i.e. colophony (wood, pine)
 - / shellac (wood, lac bug)
