# MANAGEMENT PLAN AND SURVEILLANCE MONITORING FOR AN URBAN LAKE IN A COASTAL TOURISTIC TOWN

MARÍA-TERESA SEBASTIÁ-FRASQUET, JOSÉ-ANDRÉS SANCHIS-BLAY,  
JUAN TORMO-FLORES, VICENT-JESÚS ALTUR-GRAU & JESÚS PENA-REGUEIRO  
Instituto de Investigación para la Gestión Integrada de Zonas Costeras (IGIC). Universitat Politècnica de València.  
C/ Paranimf, 1. Grau de Gandia 46730 (Valencia, Spain).

This paper is part of the Proceedings of the 3<sup>rd</sup> International Conference on Environmental and Economic Impact on Sustainable Development (Environmental Impact 2016)

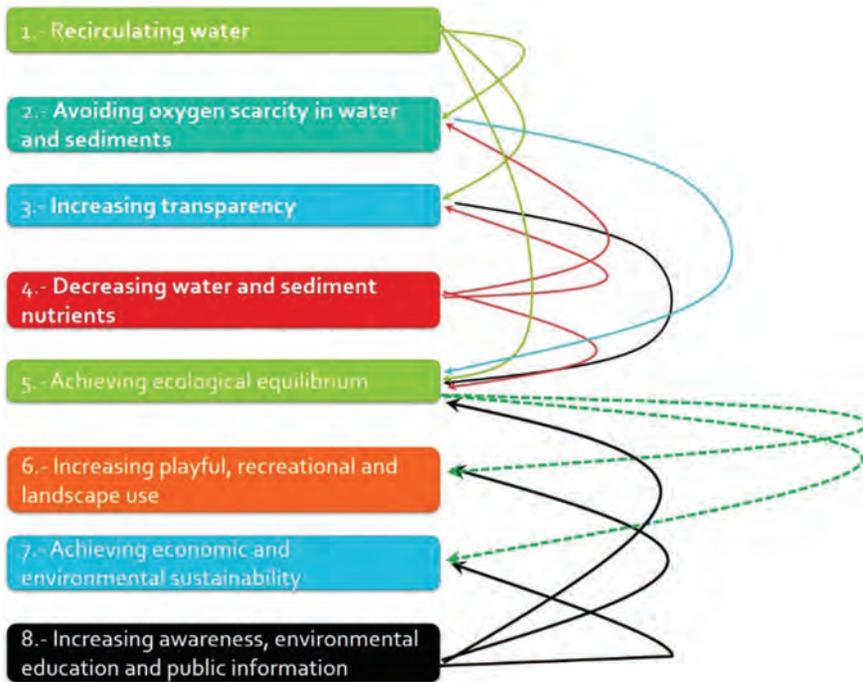
Figure 3: Restoration measures objectives. For achieving these objectives, the following measures are proposed.

The objectives of restoration measures are summarised in the following figure 3; each objective relates to the others as represented by arrows.

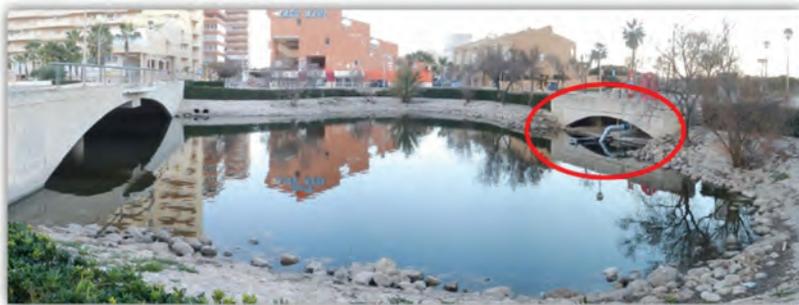
Figure 4: Infrastructure for pumping water towards the sea.

Objective: recirculating water (Figure 4)

Advantages: needed infrastructure existent, pump already installed (see Figure 4)

Disadvantages: bad groundwater quality, nitrate concentration higher than 50 mg/L. Pumping energetic cost.

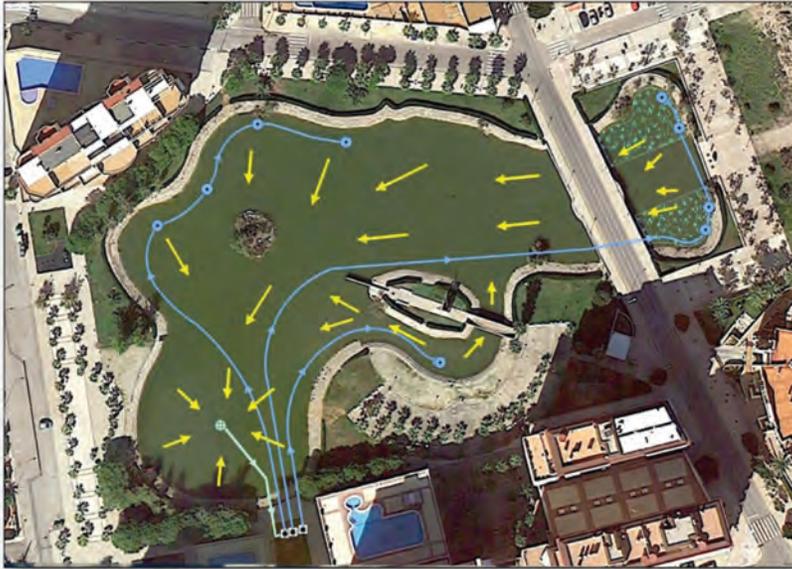
Figure 5: Closed recirculation system.

Objective: recirculating water (Figure 5)

Advantage: effective recirculation will increase aeration and increase water quality, reduced electric power needed.

Disadvantages: energetic cost and infrastructure cost

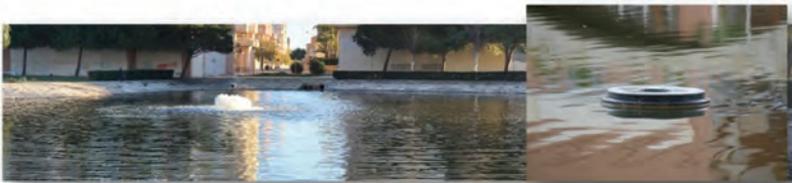
Figure 6: Aerators operating in La Goleta Lake.

Objective: increasing dissolved oxygen (Figure 6)

Advantages: already installed, the recirculation system will help in mixing oxygenated water

Disadvantages: electric energy cost, need to work together with recirculating system for improved efficiency

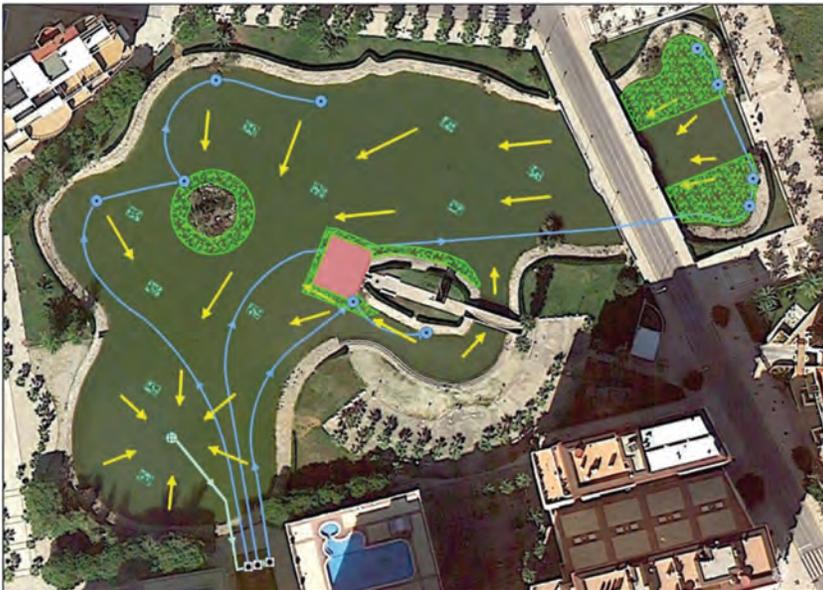
Figure 8: Simulation of biofilters in La Goleta Lake (arrows representing the recirculating water system).

Objective: increasing dissolved oxygen, increasing transparency, decreasing nutrients, ecological equilibrium, increasing landscape value and economic and environmental sustainability (Figure 8).

Advantages: increase dissolved oxygen, reduce nutrients, reduces other contaminants, permanent results, sustainable measure, increase landscape value

Disadvantages: more time needed for results (not immediate results), maintenance is needed

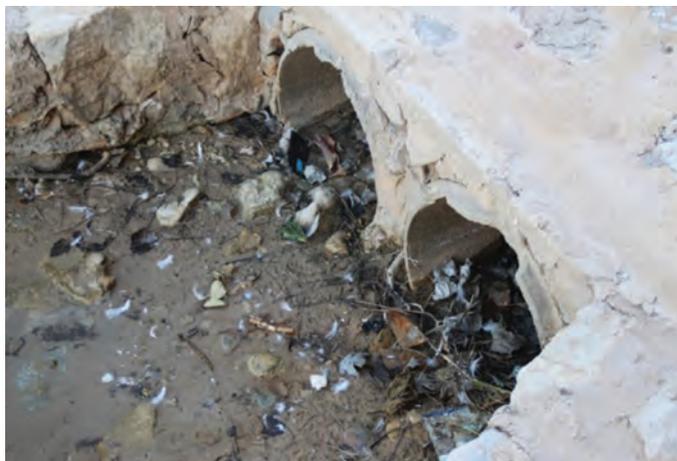
Figure 9: Filtering systems must be installed before water inputs.

Objective: increasing transparency (Figure 9)

Advantages: suspended solids and nutrients reductions

Disadvantages: installation and maintenance cost
