# Extrados Vaults in the Chartreuse of San Giacomo in Capri, Italy: History, Knowledge and Conservation of a Vernacular Architecture in the Mediterranean Landscape

**Topic:** T1.4. Restoration and conservation of vernacular architecture

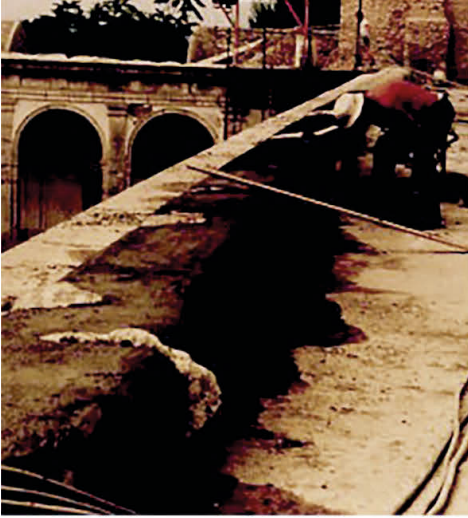
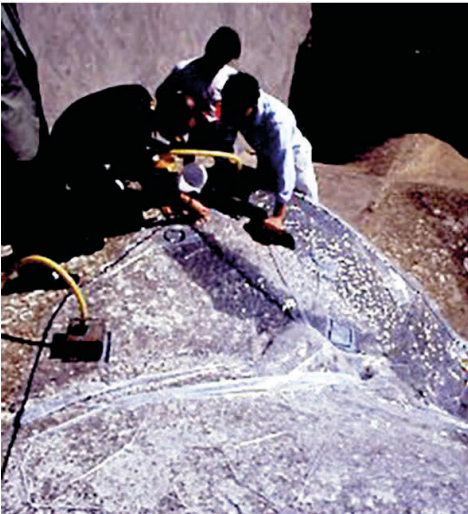
Fig. 2a & 2b – Two slides of 1980's intervention on extrados vaults system (Photographic Archive of Suprintendence of Naples, slides 017A, 067B).

Since the second half of the 20th century, numerous maintenance interventions have been carried out on the chartreuse and its vaulted system (Fig. 2a & 2b). We can easily identify them by different chromatic values between original lapillus aggregate and modern interventions of mending (Fig. 3). However, these interventions are not fully compatible with lapillus aggregate, not only for an aesthetic instance. Documentation preserved in the Superintendence Current Archive indicates that many cementitious injections have been applied over time. A more robust evaluation of the vaults' conservation is essential, especially as they continue to be exposed to degrading environmental agents.

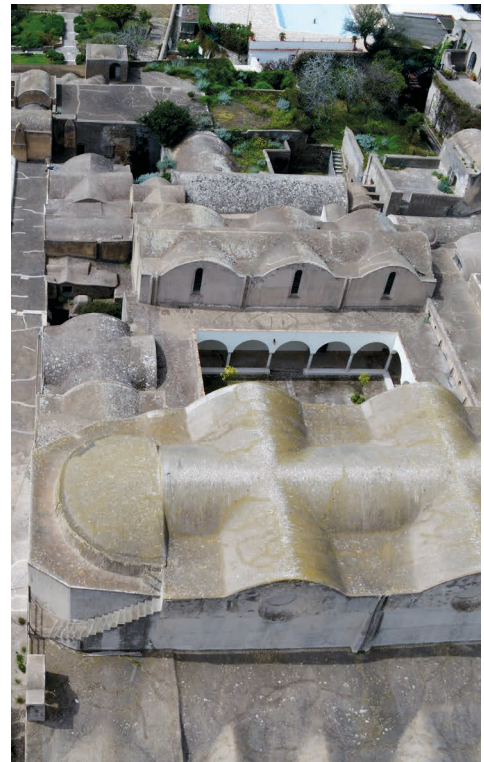
Fig. 3 – Extrados vaults of Chartreuse of San Giacomo in Capri. It's evident the presence of different forms of degradation on roof surfaces and, at the same time, the different kind of cementitious integrations (Facchini, 2018).

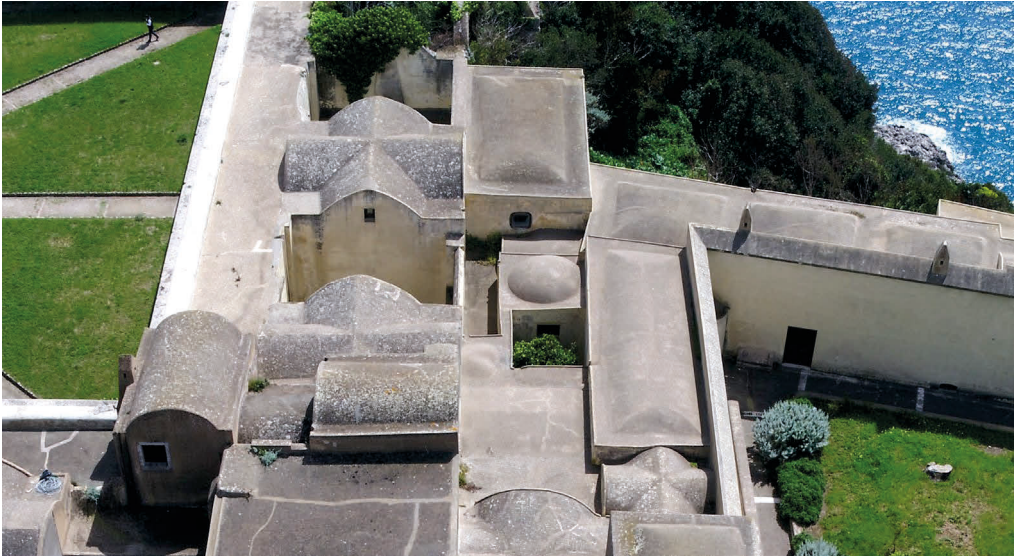
Fig. 4 – Extrados vaults of Chartreuse of San Giacomo in Capri next to the Quart of Prior (Facchini, 2018).

This evaluation can be significantly informed by the fact that today the monastic complex is part of the Ministry of Culture's heritage. Since July 2024, it has also housed the *Archaeological National Museum of Capri* in the beautiful rooms of the Quarter of Prior (Fig. 4). As a result, the monument is subject to maintenance and receives funding for larger interventions in specific areas.
