Effects of autogenous healing on the recovery of mechanical performance of High Performance Fibre Reinforced Cementitious Composites (HPFRCCs): Part 1

Liberato Ferrara, Visar Krelani, Fabio Moretti, Marta Roig Flores, Pedro Serna Ros

To appear in: Cement and Concrete Composites

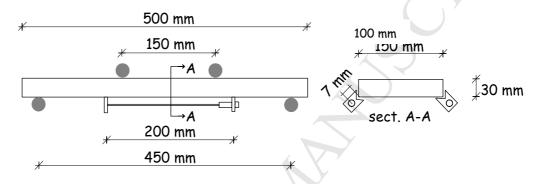
Figure 2. 4-point bending tests set-up for beam specimens obtained as in Figure 1.

After two or eleven months aging in lab environment, beam specimens were tested in 4-point bending, according to the set-up shown in Figure 2. Tests were performed controlling the actuator displacement, which was applied at a rate equal to 5 μm/sec, and measuring the Crack Opening Displacement (COD) at the beam intrados over a gauge length equal to 200 mm. The test set-up complies with Model Code 2010 guidelines on the design of SFRC structures, where material characterization through tests on un-notched beams is recommended in the case of either structural elements in bending less than 150 mm deep or strain/deflection-hardening FRC, which both apply to the present study. Results of typical tests on specimens bent parallel or perpendicular to

After the scheduled exposure times, specimens were removed from the conditioning environment, wiped, in case, and, after drying them in lab environment for a few hours, tested up to failure according to the same set-up shown in Figure 2. Superposition between pre-cracking and post-conditioning σ_N -COD curves allowed the evaluation of self-healing capacity and its effects on mechanical performance of the material, as a

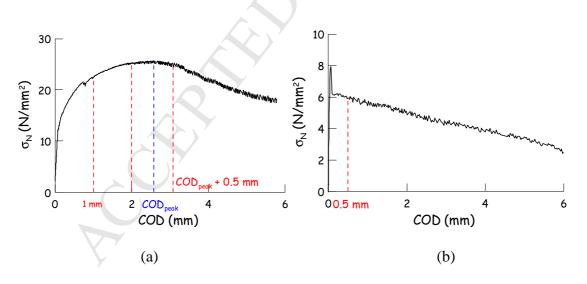
Figure 3. Nominal stress σ_N vs. COD curves for specimens featuring: (a) stable prepeak multi-cracking and deflection hardening behaviour (fibres parallel to the bending axis); (b) unstable post-cracking localization and deflection softening behaviour (fibres orthogonal to the bending axis).

the preferential fibre alignment are shown in Figure 3, in terms of nominal bending stress vs. COD curves: the material evidently features a deflection-hardening or softening behaviour whether stressed parallel or orthogonal to the aforementioned flow induced alignment of the fibres. The deflection-hardening behaviour was the result of a stable multi-cracking process in the central part of the specimen (Figure 4a), made possible by the favourable alignment of the fibres with respect to the applied stress; on the other hand, an unfavourable alignment of the fibres resulted in a single unstably propagating crack (Figure 4b). As from the image in Figure 4a, an average crack spacing of about 15 mm, of the same order of magnitude of the fibre length was obtained in all deflection hardening specimens.

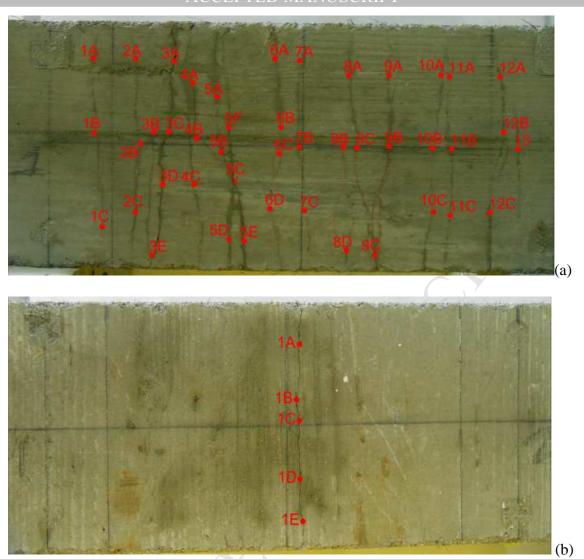
Figure 4. Crack patterns in specimens featuring: (a) stable pre-peak multi-cracking and deflection hardening behaviour (curve in Figure 3a); (b) unstable post-cracking localization and deflection softening behaviour (curve in Figure 3b).

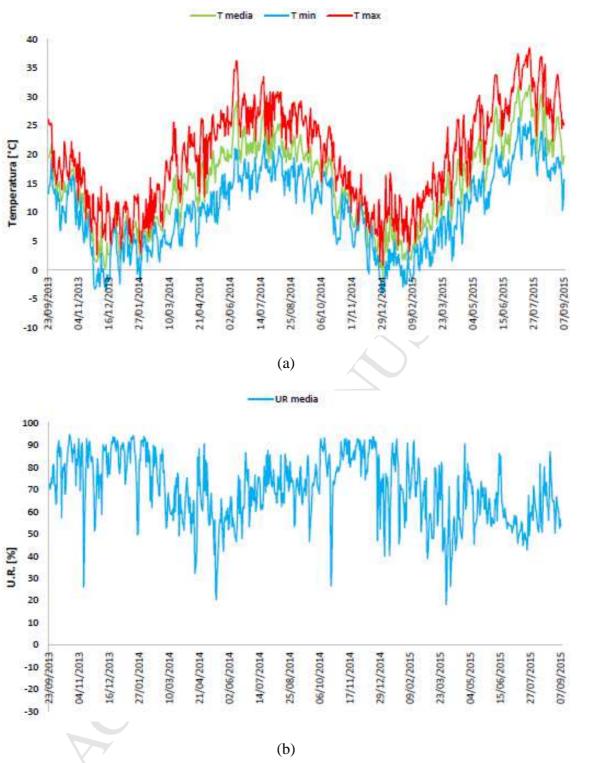
Figure 5: trends of average and minimum and maximum temperatures (a) and of relative humidity (b) in Milan all along the exposure time of specimens

including: immersion in water at 20° C; exposure to open air in the lab courtyard (temperature and humidity were daily monitored – recorded trends all along the exposure time are shown in Figure 5); exposure in a chamber at constant temperature T = 20° C and relative humidity RH = 95%; exposure in a chamber at constant temperature T = 20° C and relative humidity RH = 50%; wet and dry cycles, consisting of one day in water and one day in the 50% RH chamber.

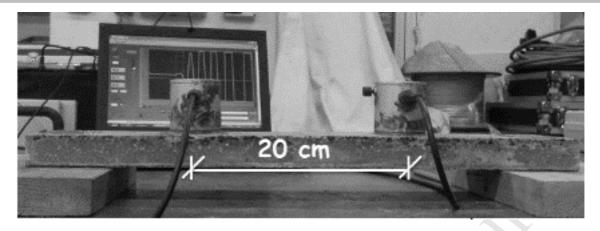
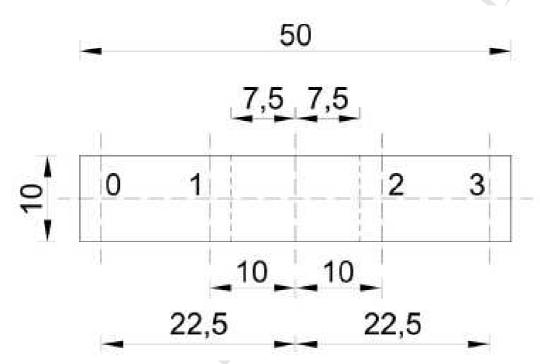
Figure 6. Ultrasonic Pulse Velocity test set-up (a) and schematic of the reference positions or UPV measurements (b): references 0 and 3 will be supports during testing whereas the zone between references 1 and 2 will undergo cracking because of the applied bending moment – measurements have been taken in zone 0-1 (for undamaged reference) and 1-2 (for cracked portion of the specimen) – measures in cm.

Ultrasonic Pulse Velocity (UPV) tests were also performed according to the set-up shown in Figure 6 at three steps: 1) before pre-cracking, 2) after pre-cracking but before starting the conditioning and 3) after conditioning but before the final failure tests. Variations in the wave speed associated with crack healing were thus evaluated. Since the wave speed in a solid medium is related to its stiffness, UPV tests provided a complementary (indirect) measure to be jointly analysed with the data garnered through mechanical tests to evaluate the recovery of stiffness. Cross comparison will be thus instrumental at assessing the reliability of the same data as well as of the tailored analysis procedure, through which "healing indices" for different analysed mechanical properties will be defined and calculated. It is worth remarking that, besides the measurements taken in the central region of the specimen (1-2 in Figure 6), which allowed to evaluate the effects of crack sealing/healing, measurements in the edge portion of the same specimen (0-1 in Figure 6) were also garnered and used to evaluate the effect due to the delayed bulk hydration. Both measurements allowed to discriminate whether the detected recovery of mechanical properties was strictly due to self-healing and/or also to delayed bulk hydration.

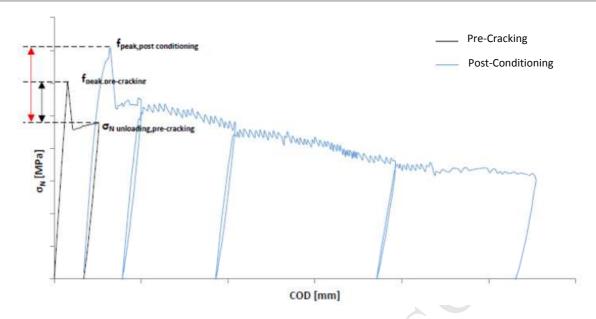
Figure 7. Notation and definition of the parameters for the Index of Strength Recovery for deflection-softening specimens.

In the case of deflection-softening specimens, the effectiveness of healing in promoting the recovery of the "through crack" residual stress bearing capacity can be evaluated by calculating the amount of strength gained after the conditioning period, with respect to the residual strength featured at the maximum pre-crack opening, and comparing it to the stress loss exhibited by the same specimen when pre-cracked up to the aforementioned crack opening threshold (Figure 7). With reference to the notation in the same Figure, the Index of Strength Recovery (ISR) is defined as follows:

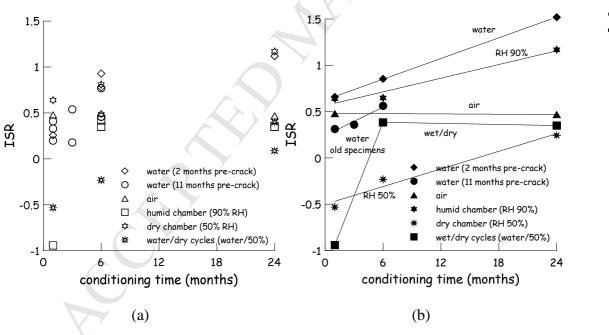
Figure 8. Index of Strength Recovery vs. conditioning time for deflection softening specimens (hollow markers refer to values of single tests (a), solid markers represent average values of nominally identical tests (b)).

- specimens immersed in water, together with specimens exposed to 90% RH, featured, in average, the highest, and a quite similar, recovery trend, able to gain, in the post-conditioning stage and after quite longer exposure times, a strength even slightly higher that the cracking strength of the virgin specimen;
- specimens pre-cracked at 11 months and immersed in water, featured a moderate and moderately increased healing capacity with prolonged immersion;
- specimens exposed to air featured an initial appreciable healing rate, but without any further significant improvement with prolonged exposure time. Besides the

discontinuous availability of water, this can be also reliably attributed to the fact that the (quite high) humidity of the environment initially triggered delayed hydration reactions, which started sealing the crack from its mouth and to such an extent to prevent further effective penetration of the water molecules, also more difficultly available because dispersed in air. Moreover, carbonation reactions, if any, only involved the Ca(OH)₂ available on the crack surfaces, no leaching from the inner matrix being possible in such a condition.

It is worth remarking that, for immersed specimens, water could penetrate deeper into the cracks and promote to a larger extent and for longer time delayed hydration reactions, originating from the tip of the crack. Moreover, being the specimens completely immersed, leaching of Ca(OH)₂ would also be possible, promoting more effective carbonation reactions with the CO₂ dissolved in the water, fully and continuously available. The precipitation of CaCO₃ crystals would be, in an initial stage, slower than leaching, thus allowing further water to penetrate and making it possible for delayed hydration reactions to proceed for longer exposure times.

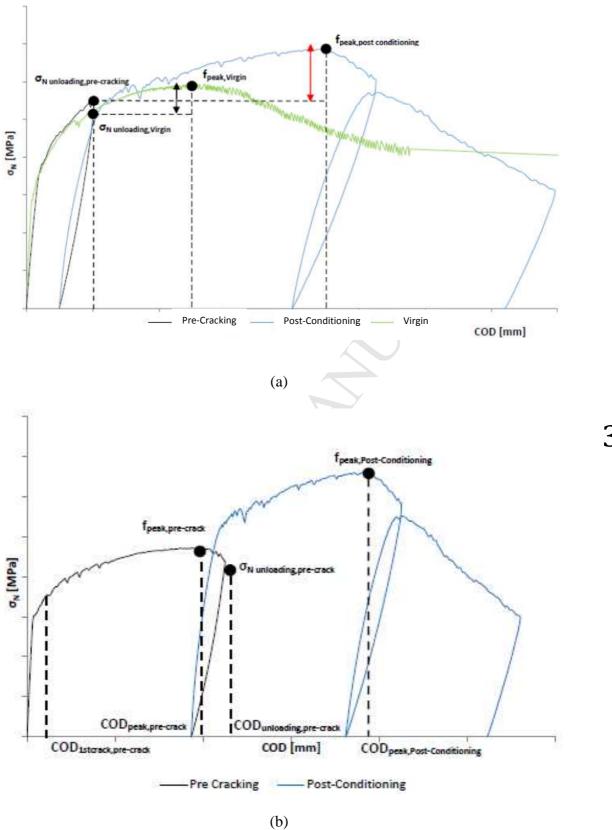
Figure 9. Definition of parameters to calculate the Index of Strength Recovery for deflection-hardening specimens pre-cracked in pre-peak (a) and post-peak regime (b).

In this framework, with reference to the notation explained in Figure 9a, the Index of Strength Recovery for deflection-hardening specimens pre-cracked in the pre-peak regime is defined as follows:

In the case of deflection-hardening specimens pre-cracked up to 0.5 mm after the attainment of the peak stress, the ISR is calculated as in Equation (1) for deflection softening specimens (Figure 9b) since, similarly to what happened for deflection softening specimens, the pre-cracking brought already the specimen into the stage of the unstable localized crack propagation. It is worth remarking that in the case of deflection-softening specimens, in which only one crack formed, the ISR does really represent what is due to the healing of that same single crack. On the other hand, in the

As it can be observed from typical stress crack-opening pre-crack and post-conditioning curves for deflection-hardening specimens (Figure 9), the self-healing reactions, besides a recovery of the load bearing capacity, assessed and evaluated as in the previous subsection, are likely to affect the deformation capacity, i.e. the ductility of the specimens. This can be clearly seen, in the case of specimens pre-cracked in the prepeak stage, from the values of the Crack Opening Displacement measured at the peak load in the post-conditioning stage tests, which are higher than the ones measured for the un-cracked virgin specimens, even after same curing time and conditions as the ones underwent by the pre-cracked specimens.

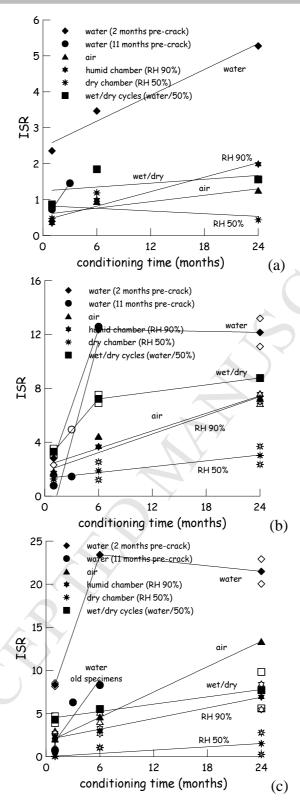
Figure 10. Index of Strength Recovery vs. conditioning time for deflection-hardening specimens pre-cracked up to 1 mm (a), 2 mm(b) and 0.5 mm after the peak (c) (hollow markers refer to values of single tests, solid markers represent average values of nominally identical tests).

The trends of ISR for deflection-hardening specimens for the different pre-crack opening cases herein investigated, are shown in Figures 10 a-c (respectively for pre-cracking up to 1 mm, 2 mm and 0.5 mm after the peak stress). With very few exceptions, which can reasonably be attributed to some random experimental scattering, the trends and influence of exposure conditions are likely to be confirmed, as discussed in detail for deflection-softening specimens. Furthermore it can be observed, as already with reference to deflection-softening specimens, that the on-going healing of cracks was also instrumental to overcome the damage that, in some cases (see e.g. specimens pre-cracked up to 0.5 mm after the peak) was caused by some non-favourable exposure conditions (dry environment, or even for older specimens immersion in water).

Significantly, in the case of specimens pre-cracked after the peak and before the peak at 2 mm crack opening, for the most favourable exposure conditions (such as water immersion or even wet and dry cycles), the recovery did not significantly proceed upon exposures longer than 6 months. As a matter of fact, the already almost completely sealed cracks may have reliably prevented any further ingress of the activator of the reaction (water) and the quite impervious matrix also prevented any further hydration of the bulk matrix. Moreover, for specimens pre-cracked at 11 months age, the recovery of the load bearing capacity was in some cases initially less significant, whereas it proceeded much faster henceforth, reasonably due to a slower activation of the delayed hydration of older un-hydrated binder particles.

The faster and, evidently, better strength recovery exhibited by specimens pre-cracked at 2 mm, than those at 1 mm, may lead us to draw some preliminary conclusions about

the effects of crack opening on the whole healing process. As a matter of fact, because of the multi-cracking, each single crack is likely to be opened, in average, between 150 and 200 µm, and about half of that, for specimens pre-cracked at 2mm and 1mm respectively. In such a crack-opening range, as also confirmed by a previous study on NSC [3], a compromise between the opening of the crack and its "healability" has to be achieved: a wider – in the range detailed above, and deeper penetrating, crack may promote better healing, in a twofold sense. On the one hand, it facilitates the ingress of water and, on the other, it exposes to the action of this a larger amount of un-hydrated binder particle clusters.

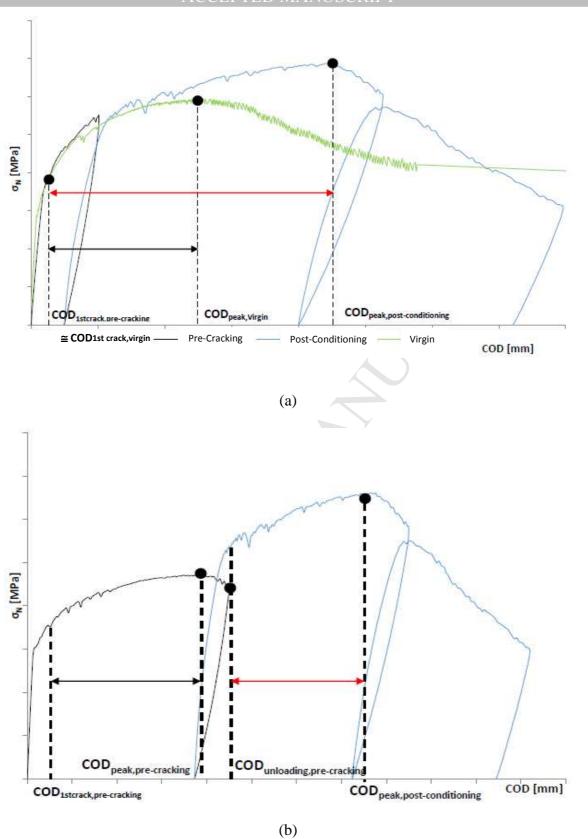
Figure 11. Notation and definition of the parameters for the Index of Ductility Recovery for deflection-hardening specimens pre-cracked in the pre-peak (a) and postpeak regime (b).

Coherently with the engineering concept of ductility, an Index of Ductility Recovery, IDuR, has been defined as follows, for specimens pre-cracked in the pre-peak stage (Figure 11a):

For specimens pre-cracked beyond the peak, IDuR is simply defined as (Figure 11b):

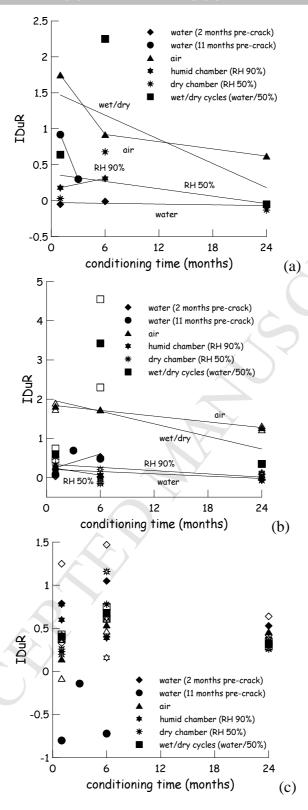
Figure 12. Index of Ductility Recovery (peak) vs. conditioning time for deflection hardening specimens pre-cracked up to 1 mm (a), 2 mm(b) and 0.5 mm after the peak (c) (hollow markers refer to values of single tests, solid markers represent average values of nominally identical tests).

It can be observed (Figures 12 a-c) that all specimens feature a recovery of the ductility, even if with a decreasing trend upon prolonged exposure and that only for some selected crack openings and exposure conditions the ductility of the healed specimens remains higher than that of the reference virgin one. Moreover, specimens pre-cracked beyond the peak provided quite scattered results for which any trend was hardly detectable, even if the worsening with respect to the virgin specimens performance was always confirmed. Interestingly, as far as the effect of the exposure conditions is concerned, it looks that the exposure to open air provides a better recovery of the ductility than immersion in water, which, on its hand, was deemed to be the most favourable conditions to healing with reference to the recovery of load bearing capacity. Finally, wet and dry cycles promote an initial quite significant gain of ductility, up to six months exposure, followed by a rather dramatic loss.

This trend can be reasonably attributed to the fact that healing products closing the crack and restoring the cross-crack continuity of the material, on the one hand restored the load bearing capacity of the material itself. On the other hand, this effect was confined to the same crack location and had scant if not detrimental effect on the stress redistribution capacity upon the re-opening of the same crack when reloading the specimen after conditioning exposure.

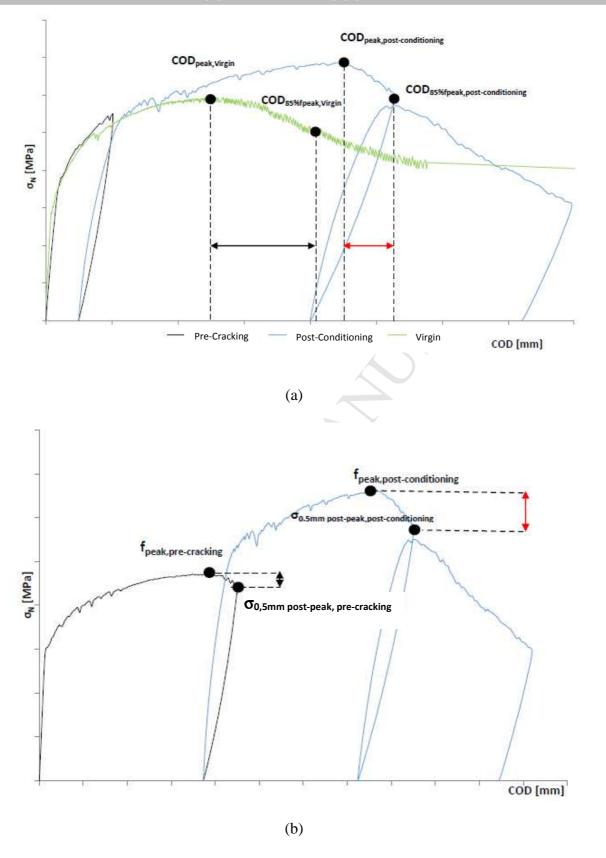
Figure 13. Notation and definition of the parameters for the Index of Ductility Recovery for deflection hardening specimens pre-cracked in the pre-peak (a) and postpeak regime (b).

In order to have a deeper insight into the effects of self-healing on the flexural ductility of the material, a different calculation procedure, rather related to the post-peak stage is hereafter proposed (Figure 13a) for specimens pre-cracked before the peak:

The index compares the crack-opening amplitude of the post peak interval for a stress decay equal to 15% of the peak strength, as in post-conditioning failure tests, to the amplitude featured by the reference virgin specimen for the same strength loss.

For specimens pre-cracked after the peak the same calculation is performed comparing the stress loss in a COD interval equal to 0.5 mm after the peak, that the same specimens features in the post-conditioning and in the pre-cracking regimes respectively (Figure 13b):

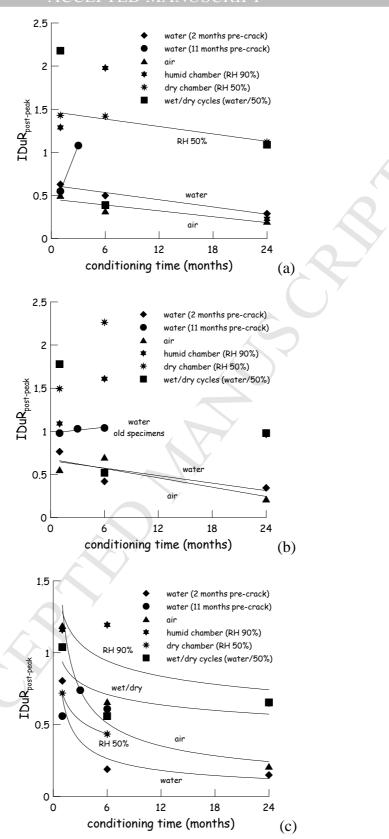
Figure 14. Index of post-peak Ductility Recovery vs. conditioning time for deflection hardening specimens pre-cracked up to 1 mm (a), 2 mm(b) and 0.5 mm after the peak (c).

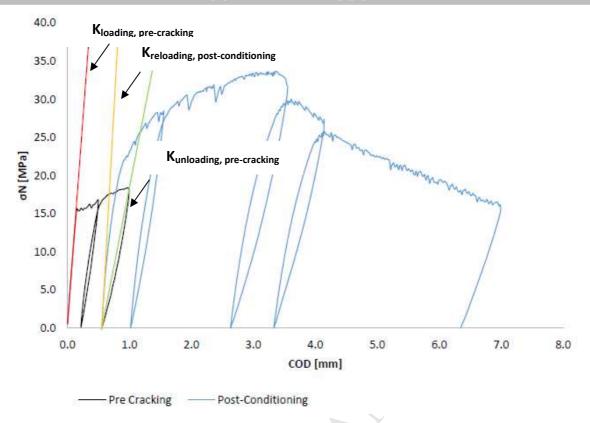
Figure 15: notation for the calculation of Index of Damage Recovery.

Thanks to unloading-reloading cycles performed both during pre-cracking and post-conditioning tests, the values of secant unloading and tangent reloading stiffness, respectively denoted as $K_{unl,j}$ and K_j , at different levels "j" of crack opening were evaluated (see Figure 15 for example). It is worth remarking that the unloading process always took place in a matter of few tenths of seconds, which is quite short for any significant relaxation to have occurred.

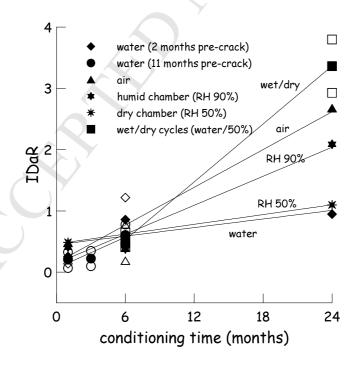
Figure 16. Index of Damage Recovery vs. conditioning time for deflection softening specimens (hollow markers refer to values of single tests, solid markers represent average values of nominally identical tests).

- deflection softening specimens exhibited a stiffness recovery ranging from moderate to significant, as a function of exposure conditions, wet and dry cycles and exposure to open air providing the best results;
- all deflection-hardening specimens, except for old specimens, featured evident stiffness recovery, with influence of exposure conditions as expectable.

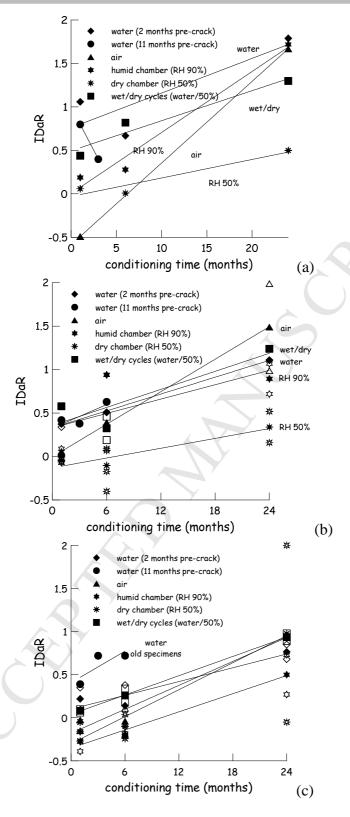
Figure 17. Index of Damage Recovery vs. conditioning time for deflection hardening specimens pre-cracked up to 1 mm (a), 2 mm(b) and 0.5 mm after the peak (c) (hollow markers refer to values of single tests, solid markers represent average values of nominally identical tests).

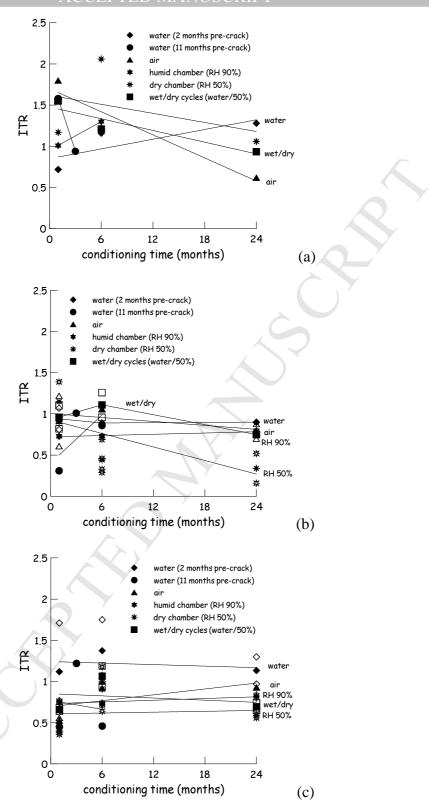
Figure 18. Index of Toughness Recovery vs. conditioning time for deflection hardening specimens pre-cracked up to 1 mm (a), 2 mm(b) and 0.5 mm after the peak (c) (hollow markers refer to values of single tests, solid markers represent average values of nominally identical tests).

Results, in Figures 18 a-c, show a trend that, generally speaking, after an initial increase upon the first six months of exposure, remains thereafter constant or decreases. It is anyway worth highlighting that in most cases the recovered performance attains levels comparable or even slightly higher that of the un-cracked reference specimens.

Effects of crack closures and of recovery of stress bearing capacity and ductility, as discussed above, can be called to explain the aforementioned trends. Significantly, and coherently with previously exposed statements about the effects of crack-opening, the performance trends of specimens pre-cracked up to 2 mm or even beyond the peak, appear to be more stable than that of specimens pre-cracked at 1 mm.

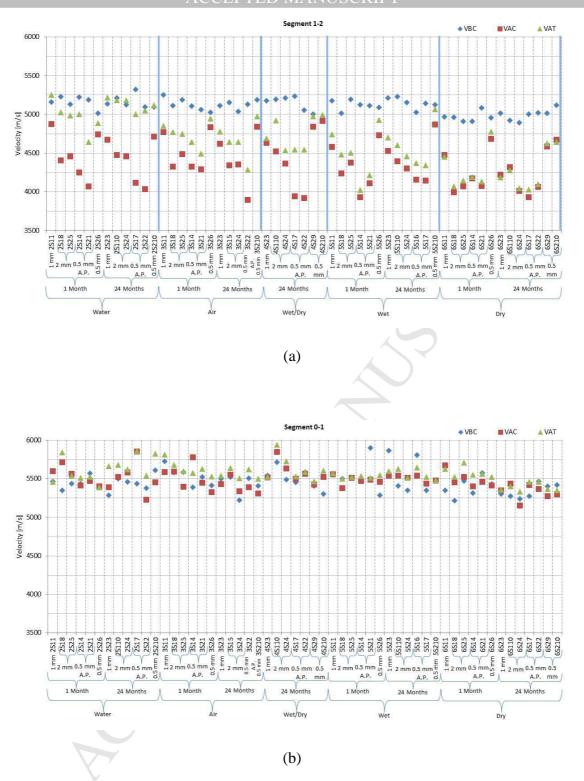
Figure 19. Ultrasonic Pulse Velocities measured before cracking (VBC in notation), after pre-cracking (VAC) and after conditioning treatments (VAT) in the central cracked (a) and in the left undamaged (b) portions of the specimens.

In Figures 19a-b the values of the velocities are plotted, as measured in the central and edge portion of the specimen respectively, and in the three aforementioned testing stages, i.e. before pre-cracking, after pre-cracking and after conditioning.

It can be immediately observed that, for the data referring to the central part of the specimen, which undergoes cracking, a significantly slower wave is detected after cracking, followed, in case and as a function of the crack-opening and exposure conditions and durations, by recovery in the post-conditioning stage. On the other hand for the data referring to the edge portion of the specimen, no relevant change is detected neither between before and after pre-cracking, nor, more significantly, between after pre-cracking and after conditioning tests. This is likely to confirm that any measured recovery of the mechanical performance featured by the specimens, as extensively discussed above, is rightly attributable to the healing of the cracks and not, or at least not very significantly, to a delayed bulk hydration that the material may undergo along time, mainly when immersed in water or exposed to humid environments.

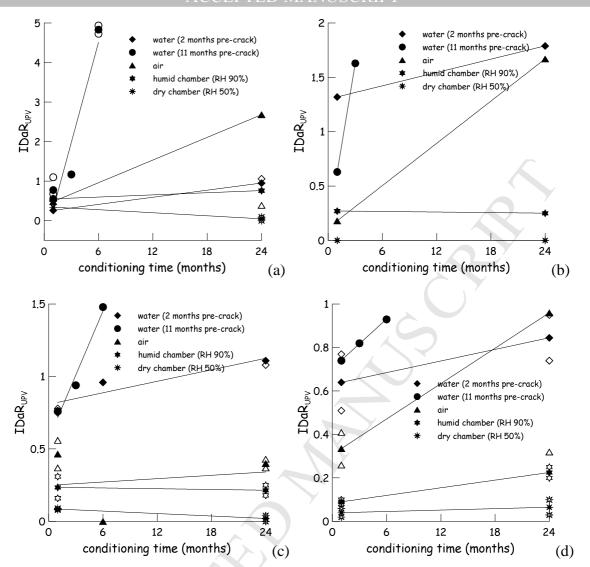
Figure 20. Index of Damage Recovery as per UPV tests vs. conditioning time for deflection softening (a) and deflection hardening specimens pre-cracked up to 1 mm (b), 2 mm (c) and 0.5 mm after the peak (d) (hollow markers refer to values of single tests, solid markers represent average values of nominally identical tests).

Figure 21: Correlation between Index of Damage Recovery as per UPV tests and Index of Damage recovery as per 4pb tests (b).

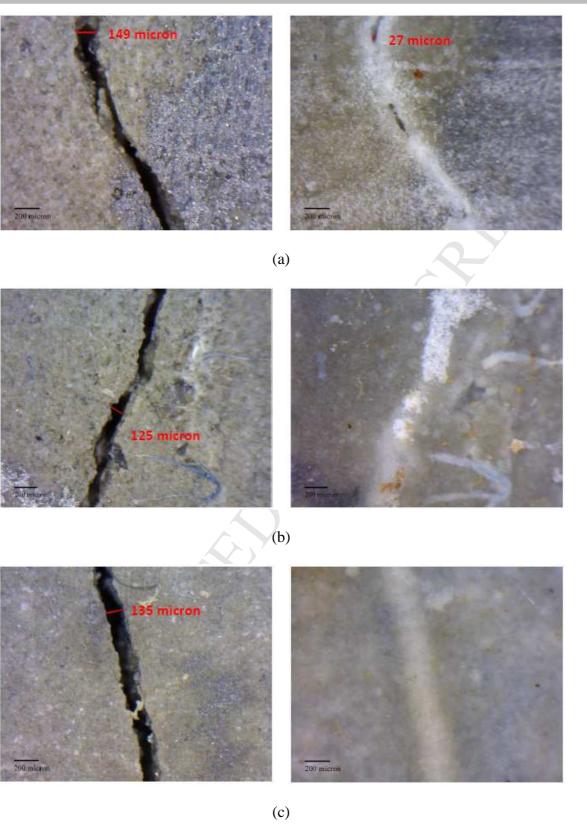
Figure 22. Examples of healed cracks of specimens pre-cracked at 2 months age and immersed in water for 1 (a), 6 (b) and 24 (c) months.

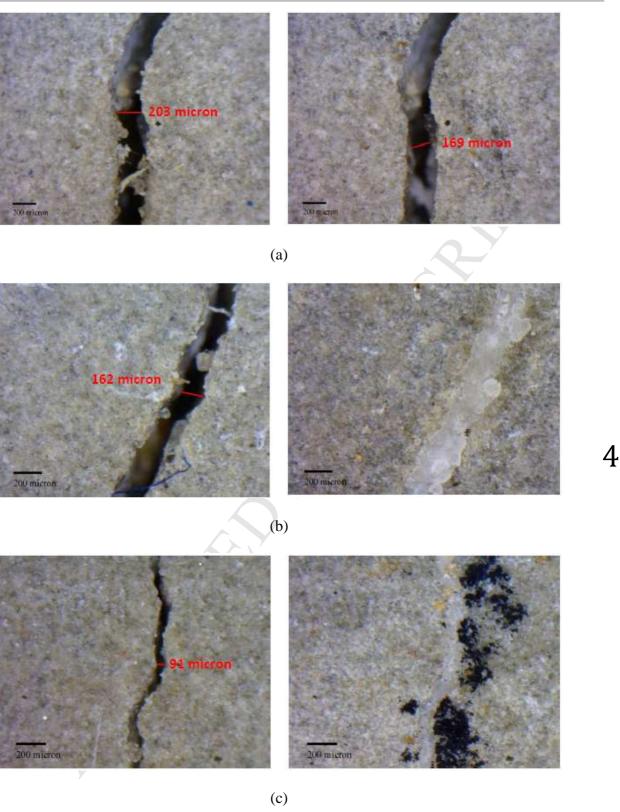
Figure 23. Examples of healed cracks of specimens pre-cracked at 9/11 months age and immersed in water for 1 (a), 3 (b) and 6 (c) months.

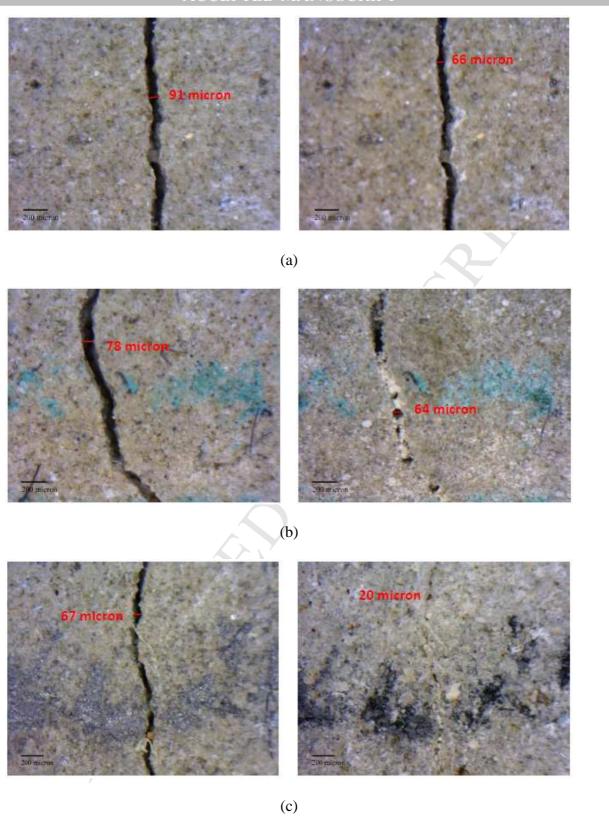
Figure 24. Examples of healed cracks of specimens pre-cracked at 2 months age and exposed to open air for 1 (a), 6 (b) and 24 (c) months.

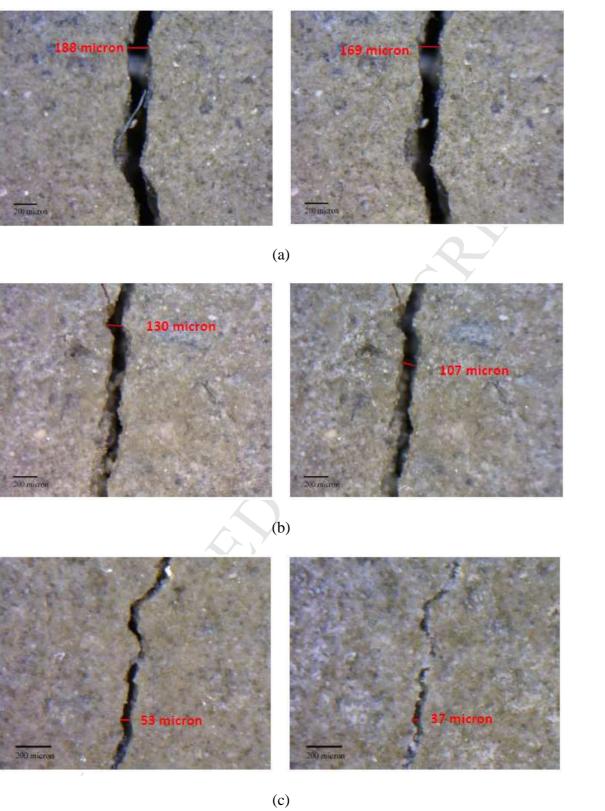
Figure 25. Examples of healed cracks of specimens pre-cracked at 2 months age and exposed to RH 90% for 1 (a), 6 (b) and 24 (c) months.

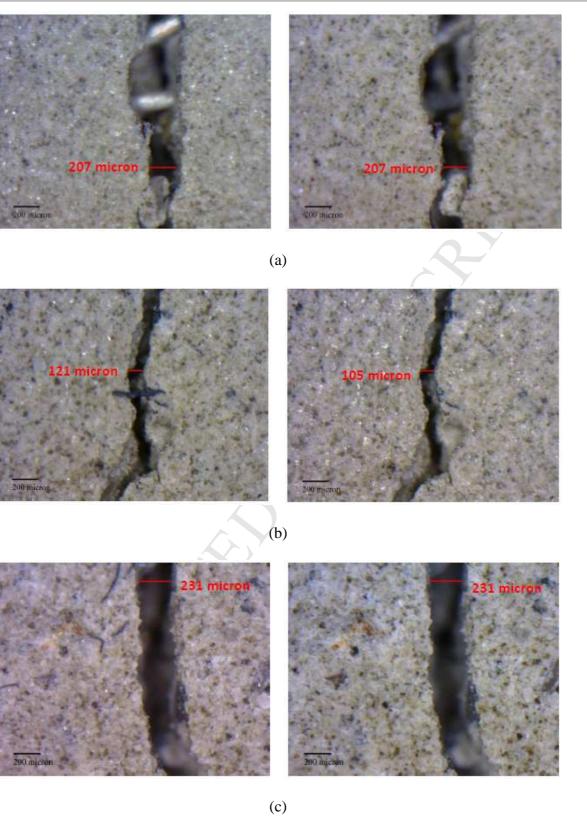
Figure 26. Examples of healed cracks of specimens pre-cracked at 2 months age and exposed to RH 50% for 1 (a), 6 (b) and 24 (c) months.

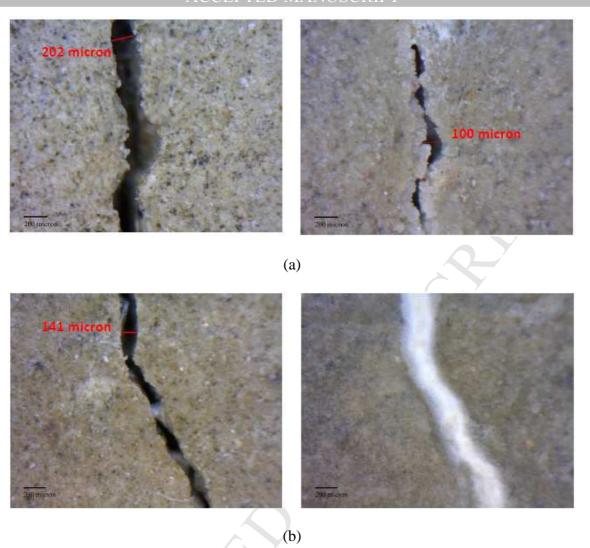
Figure 27. Examples of healed cracks of specimens pre-cracked at 2 months age and exposed wet and dry cycles for 1 (a) and 24 (b) months.

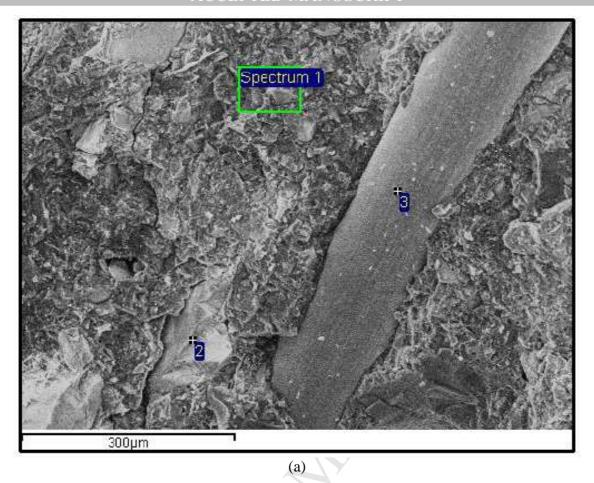
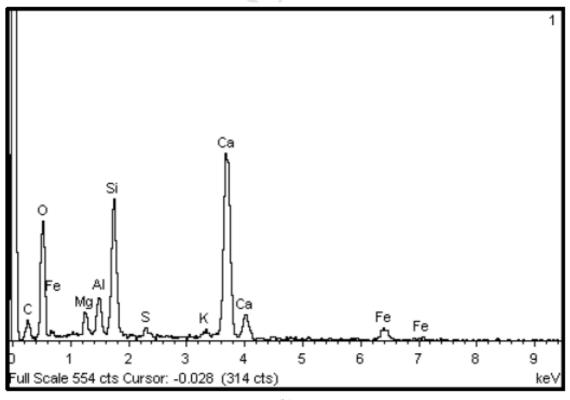
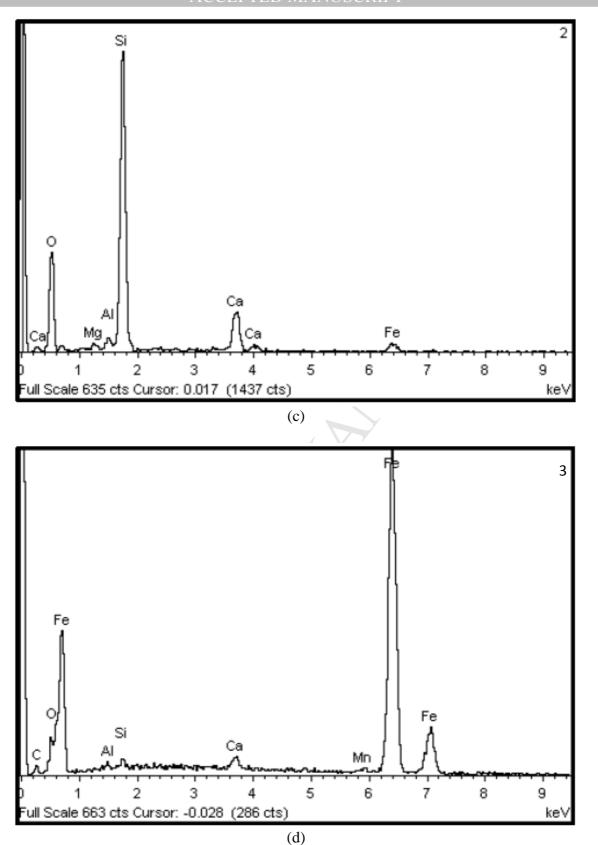
Figure 28. Microscopy image of a "healed" fracture surface (a) and SEM analysis of cement paste (b), sand grain (c) and a fibre (d).
