After the earthquake. Design processes for intervention on vernacular heritage in Central Italy

Topic: T4.1. Conservation and restoration projects of vernacular architecture

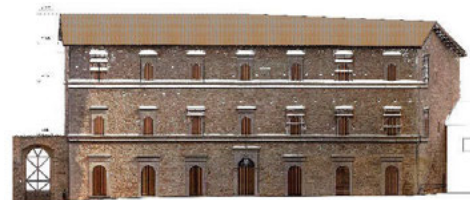
Fig. 2. The southern elevation of “Palazzo delle Guate” (Source: Archiving, 2020)

After this assessment, the technicians involved in the process and the owner of the building – that is, the Camerino’s diocesan chancery (*Curia*) – work together to set the goals for the structural and architectural design. The main objectives of this work are seismic security and accessibility, modern hygienic standards, and fire prevention. Overall, the Shrine is an important local monument: this means that memory and image of the complex become important elements during the design phase (Fig. 2).
