Gyftakis, KN.; J. Antonino-Daviu; Garcia-Hernandez, R.; Mcculloch, MD.; Howey, DA.; Marques Cardoso, AJ. (2016). Comparative Experimental Investigation of Broken Bar Fault Detectability in Induction Motors. IEEE Transactions on Industry Applications. 52(2):1452-1459. doi:10.1109/TIA.2015.2505663

Comparative Experimental Investigation of Broken Bar Fault Detectability in Induction Motors

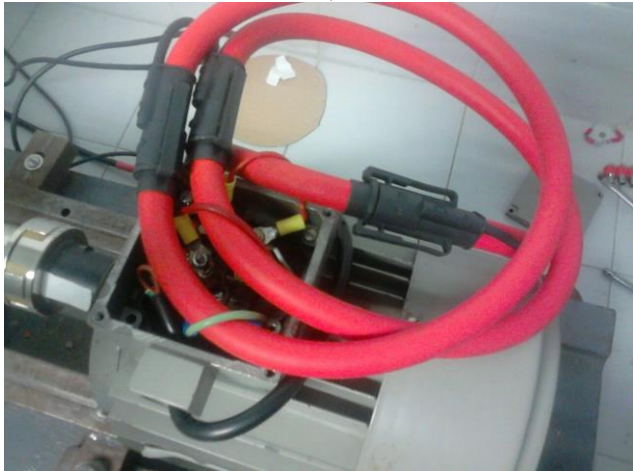
Fig. 1. The test bench where it is shown: a) the coupling between induction motor and load and b) the current sensors configuration.

The test bench as well as the current sensors configuration is shown in Fig. 1. A DC generator was coupled to the motors shaft playing the role of the load. The variable voltage was regulated by means of an autotransformer that was connected at the output of the supply desk. The autotransformer enabled to vary the supply voltage in a wide range (from 0 to the rated voltage of the motor). The three phase currents were monitored for every operating case using current clamps that were connected to a waveform recorder (YOKOGAWA DL-850). The signals were captured at a sampling rate of 5 kHz and the register length was 100 seconds, which gives a good resolution for the FFT analyses. The current signals were initially stored in the recorder and afterwards transferred to a computer. Moreover, the tested induction motor characteristics are shown in Table I.

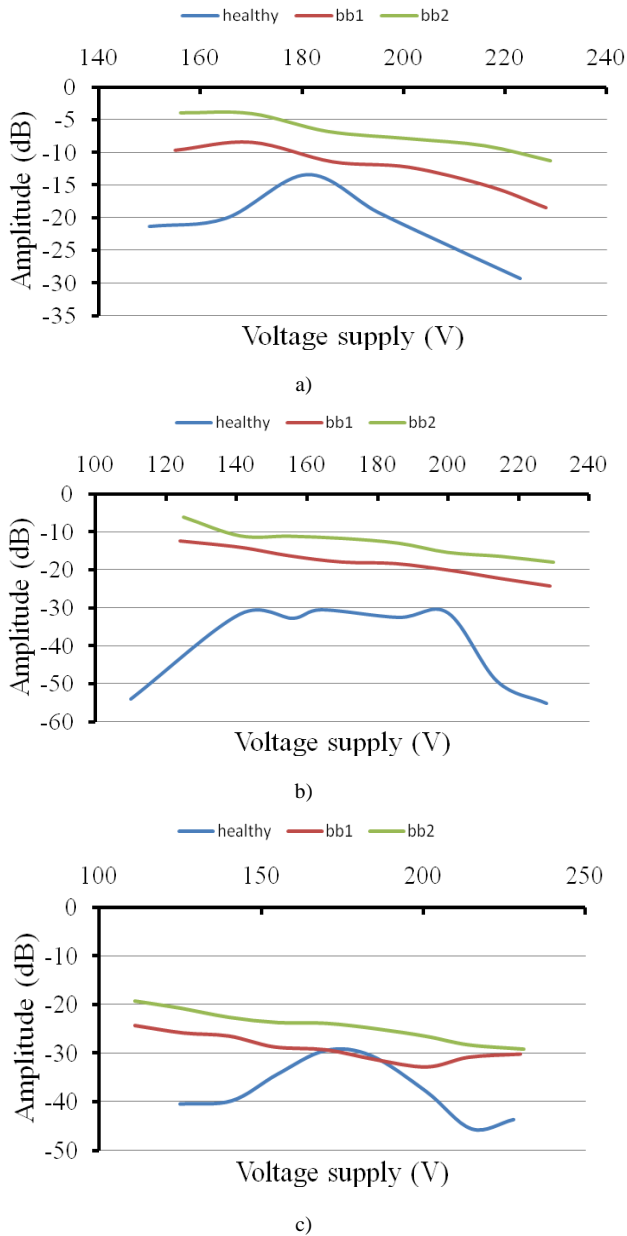
Fig. 7. The amplitude of the 3fs-2sfs broken bar fault signature versus the voltage supply level for: a) nominal load, b) half nominal load and c) no load operation.

In this subsection, the impact of voltage supply and load level on the broken rotor bar fault signatures of the ZSC spectrum will be shown. For this purpose, measurements at three different load levels: nominal, half nominal and no-load were conducted. For each load level, different voltage levels were studied. After analysis, the amplitudes of the $3f_s - 2sf_s$ broken bar fault signatures were extracted from all cases and plotted (Fig. 7).

It can be seen that for nominal load and half nominal load the proposed ZSC signature is fault severity sensitive for every voltage supply level. Similar is the behaviour at no-load operation except some small variation of the signatures amplitude in the healthy motor. This was caused by a random shaft oscillation, which if it happens at no-load, it can significantly influence the current harmonic index due to the rotor irregular movement.

- As it can be seen from Fig. 7 the ZSC is a diagnostic tool that is sensitive to the severity of the fault. Voltage supply level can influence the diagnosis for no load operation as it can be seen in Fig. 7-c but diagnosis at operation under load is reliable.
