Daugiabučio gyvenamojo namo Trakų g. 14 Vilniuje rekonstrukcijos projektavimas
Reconstruction planning of the multi-dwelling residential building at Traku str. 14 in Vilnius

FINAL THESIS WORK

VILNIUS, 2013

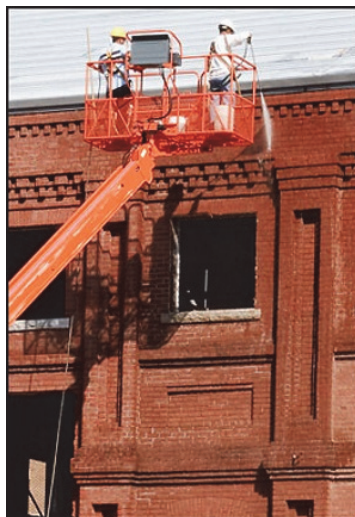
Figure 52. Example of water washing

Non-ionic detergents added to a low- or medium-pressure water wash can be a very useful aid. (A non-ionic detergent, unlike most household detergents, does not leave a solid, visible residue on the masonry.) Adding a non-ionic detergent and scrubbing with a natural bristle or synthetic bristle brush can facilitate cleaning textured or intricately carved masonry. This should be followed with a final water rinse.

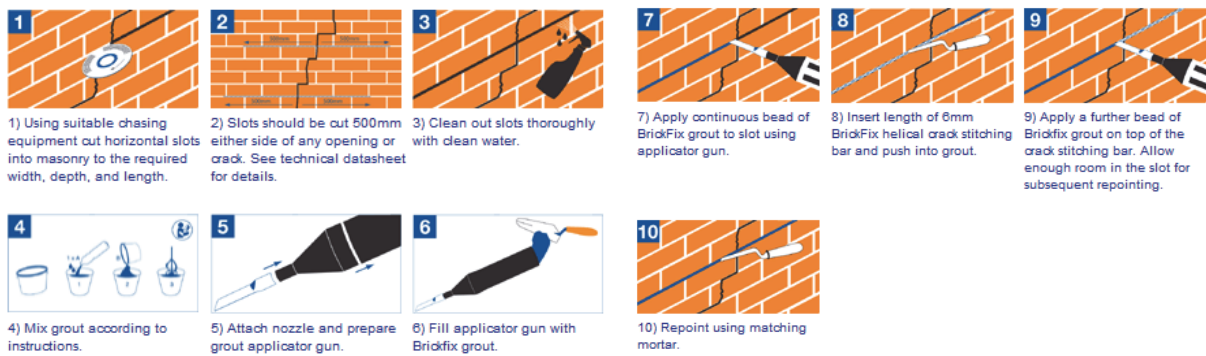
Figure 60. Process of Brickfix Crack Stitching System method

The next pictures show the material (Figure 59) and the process of the Stitching (Figure 60) used for the reparation of cracks in walls with Brickfix Crack Stitching System method.

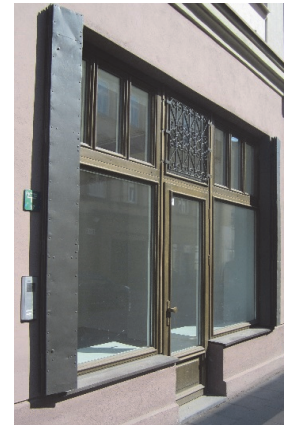
Figure 78. Protection grille

The solution adopted is to place a gate hinged metal that will be used to protect the glass windows of the main street facade. In the next pictures (Figure 77, Figure 78) is possible to see the replacement of all the doors and windows of this facade as well as the rehabilitation of the sockets and repainting the entire facade.
